Champions Way Homeowners Association, Inc.

August 9, 2023 • South Bend, IN

RESERVE STUDY

Champions Way Homeowners Association, Inc.
South Bend, Indiana

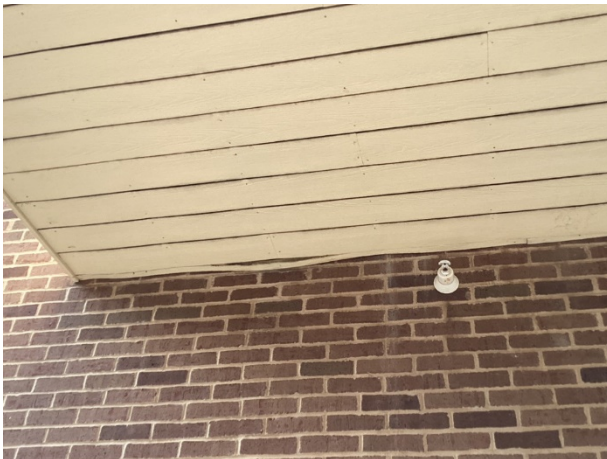
We note systematic soffit deflection and isolated stains. These conditions are likely caused by water accumulation which may lead to premature deterioration of the frame and the need for replacement if not properly maintained. We recommend Unit Owners conduct periodic inspections and remediation to ensure water drains properly through the soffit. We estimate costs of full balcony soffit replacement and necessary frame repairs at approximately \$1,300 per balcony. However, the exact cost may vary based on the exact scope of frame deterioration and coordination of repairs.

Soffit displacement at the unit owned balcony

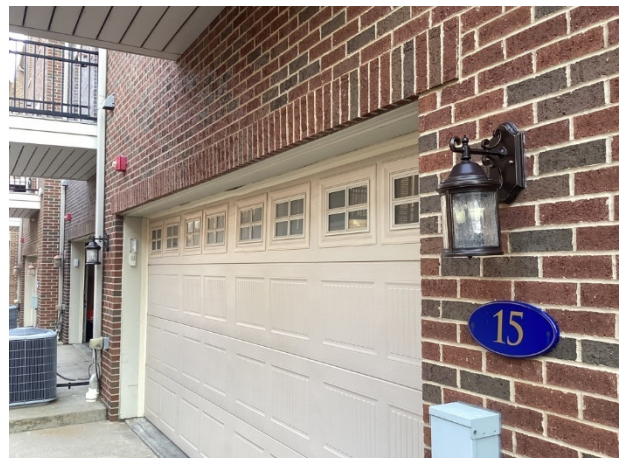
Condition: Fair overall with finish deterioration and mis-matched fixtures evident. We note replaced fixtures.

Replaced light fixtures

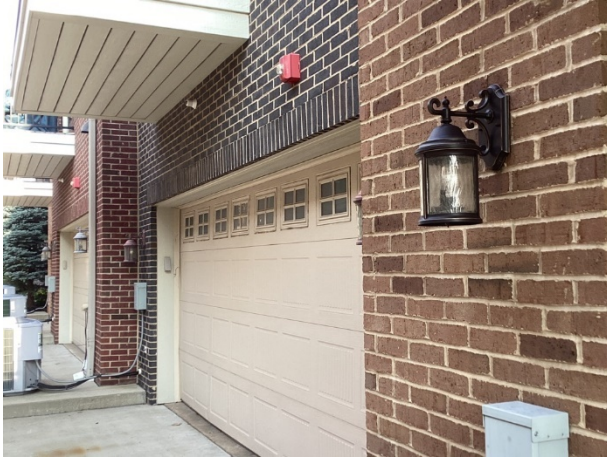
Mismatched finishes

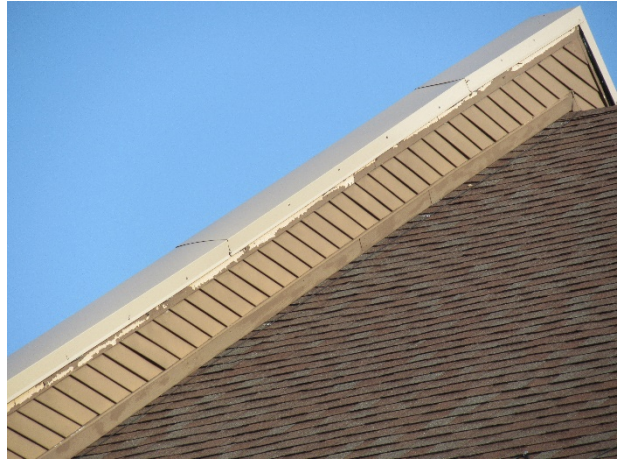
Condition: Upon completion of the renovation, we assume satisfactory condition. The paint finishes are in fair overall condition.

Parapet walls overview with minor finish deterioration

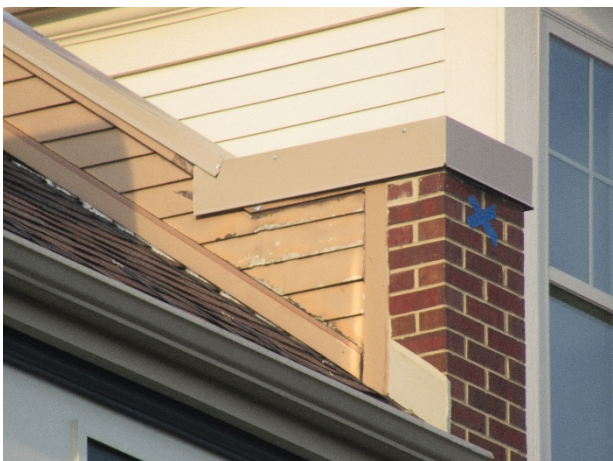
Parapet wall finish deterioration

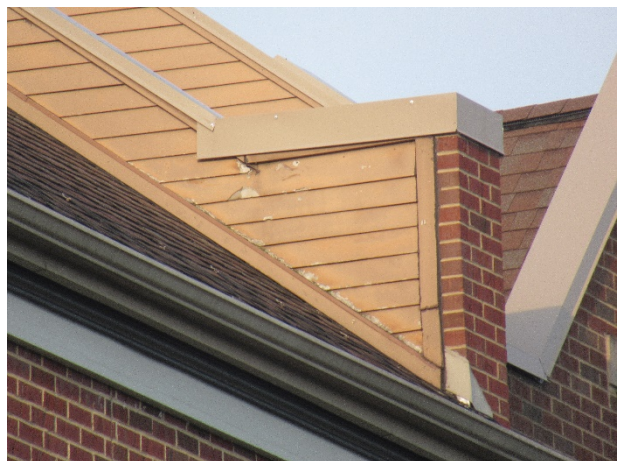
Parapet wall finish deterioration

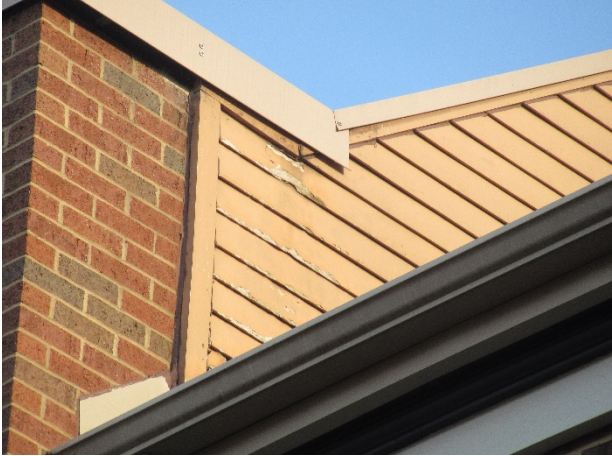
Parapet wall finish deterioration

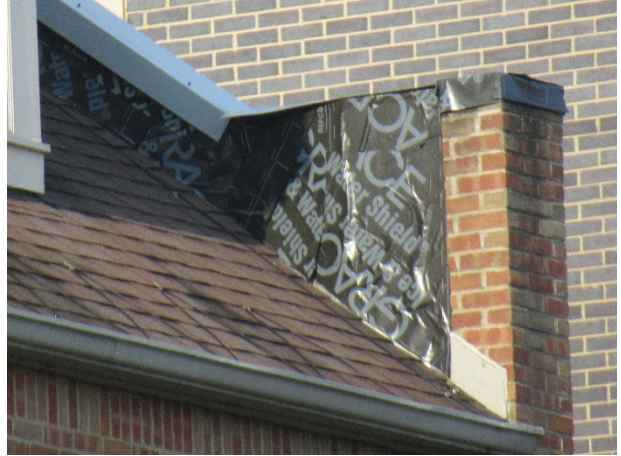
Missing siding at parapet wall – Note: ongoing repairs, we assume installation of siding in near term

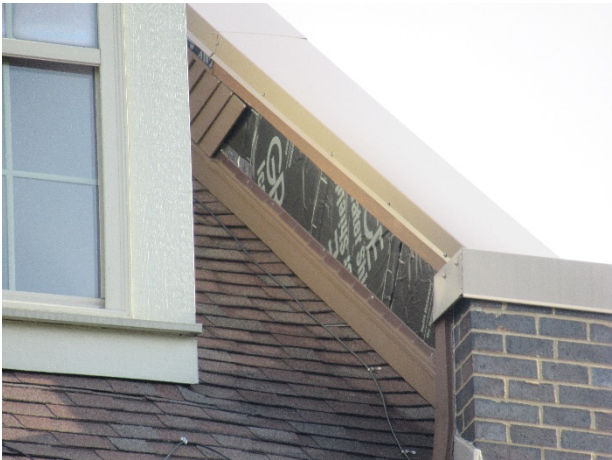
Missing siding at parapet wall – Note: ongoing repairs, we assume installation of siding in near term

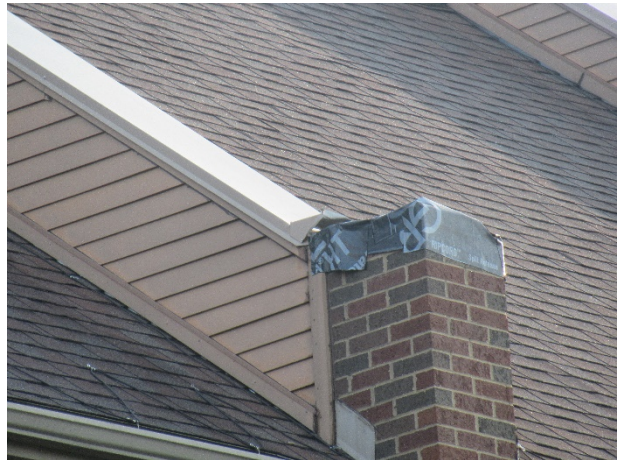
Aluminum wall cap missing – Note: ongoing repairs, we assume installation of cap in near term

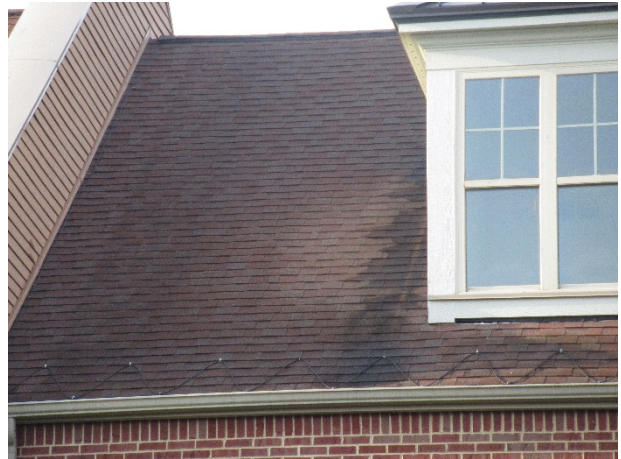
Condition: Good to fair overall with staining, minor shingle lift, and isolated sheathing deflection. Management reports a limited history of leaks at the parapet walls. Following the recent remediation of the parapet walls, Management does not report leaks.

Asphalt shingle roof staining

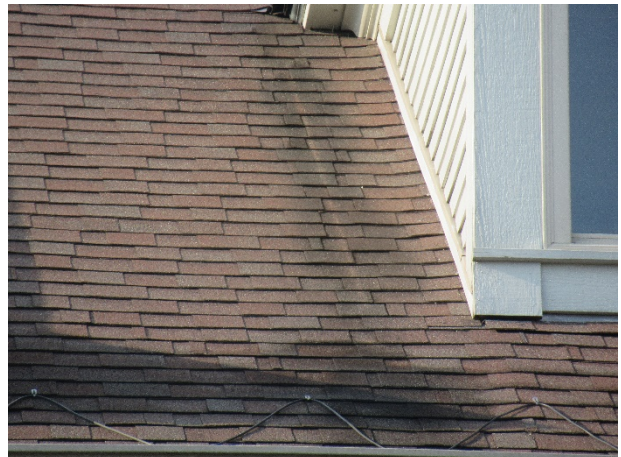
Asphalt shingle roof staining

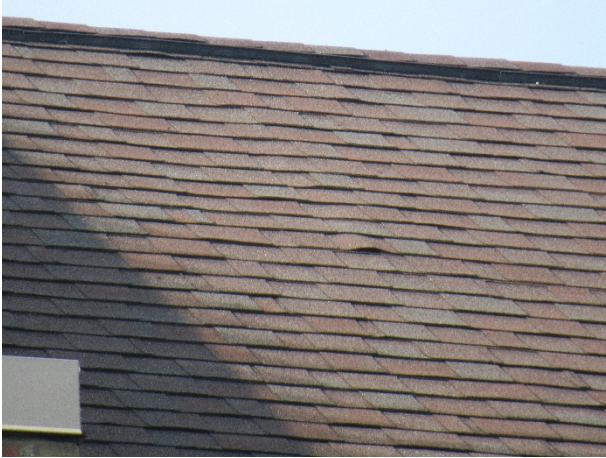
Minor shingle lift

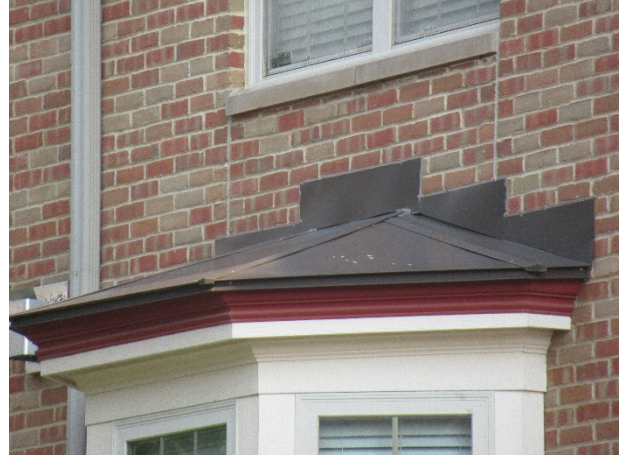
Metal roof with minor finish deterioration

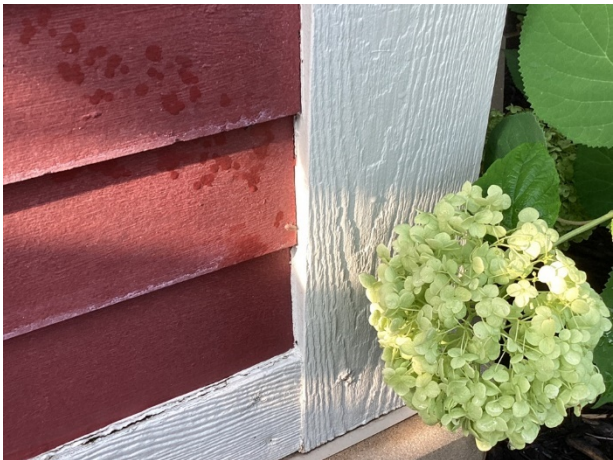
Condition: Fair overall with cohesive failure, adhesion failure, brittle sealants, sealant cracks and missing sealant evident. We note a lack of sealant along the fiber cement-composite joint at the front bays. We recommend the Association seal these areas to prevent water infiltration.

Lacking sealant at Unit 45

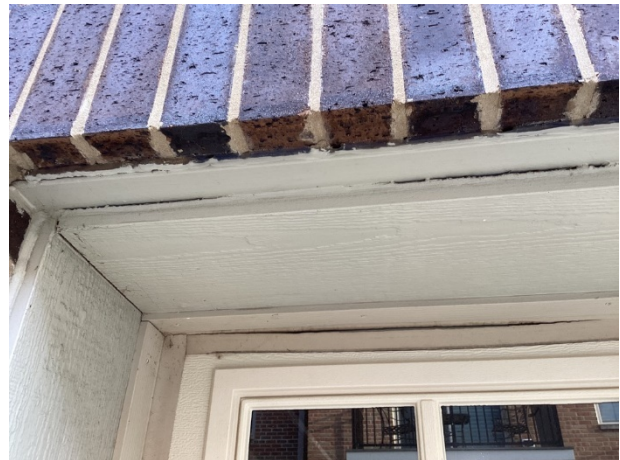
Cohesive failure above garage

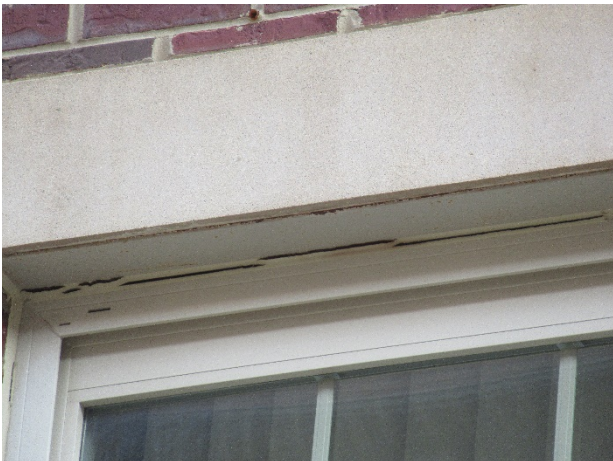
Sealant failure at window at Unit 72

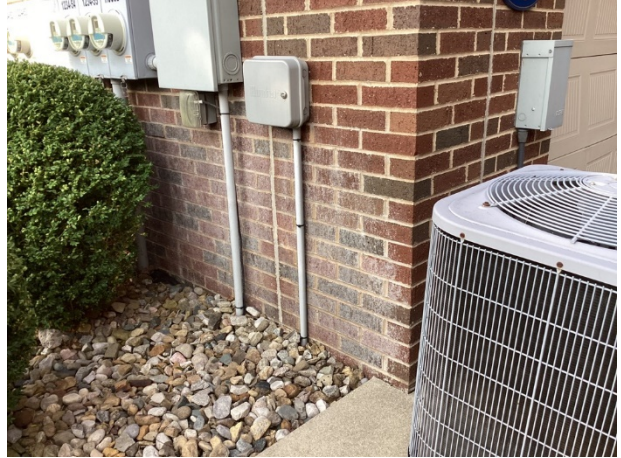
Efflorescence at Unit 55

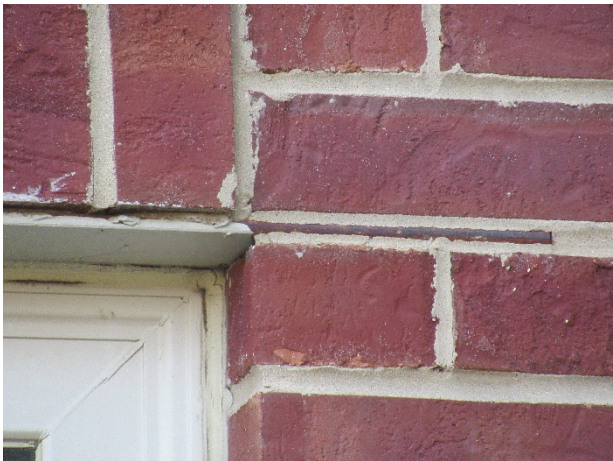
Rust jacking

We recommend an inspection, repair and replacement of the steel lintels. Lintels are structural supports or beams above windows and doors. Fatigued lintels also allow the direct penetration of storm water into the wall assembly. These inspections should locate areas of rust on the lintels and cracks or other structural damage to the walls around lintels. The contractor should remove any areas of rust, prime and paint these lintels. Paint protects and maximizes the remaining useful life of the lintels and therefore the exterior wall systems. We include costs of paint finish applications of the steel lintels in Line Item, "**Walls, Siding and Trim, Composite**". Structural damage can eventually lead to costly replacements of lintels and surrounding wall systems.

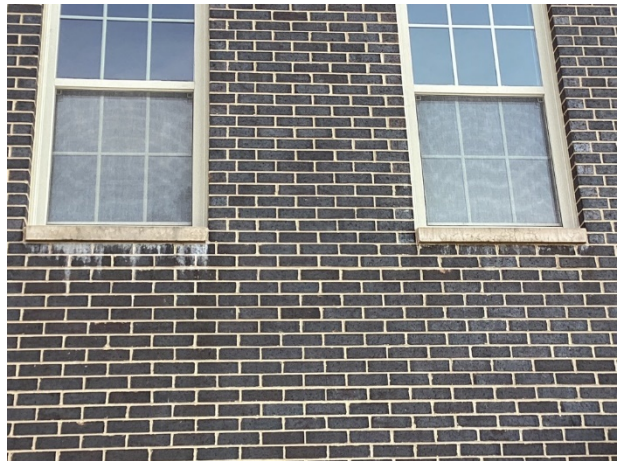
Efflorescence and sill cracks at Unit 92

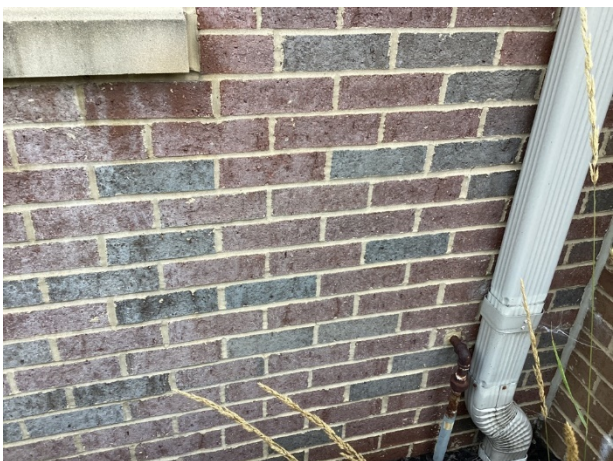
Efflorescence and masonry cracks at Building 2

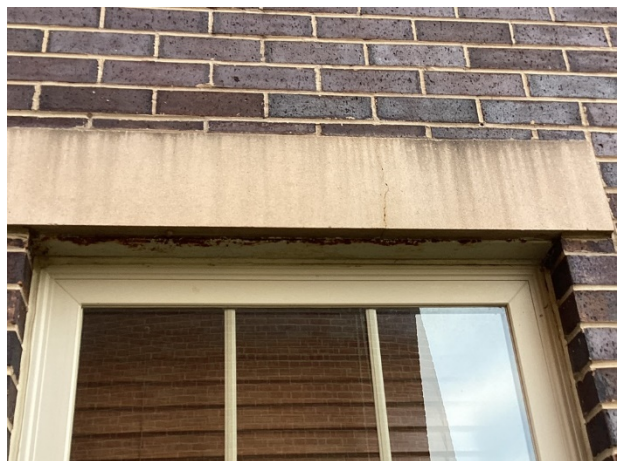
Lintel rust and cast stone crack

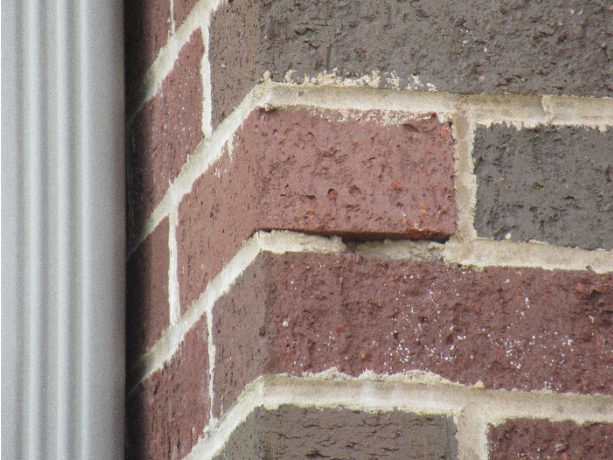
Mortar loss

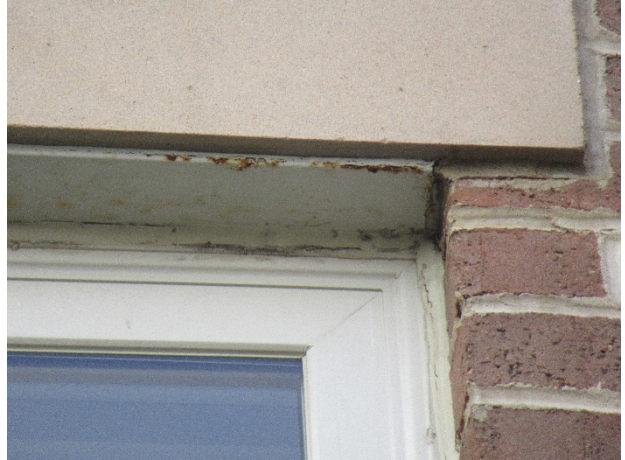
Lintel rust

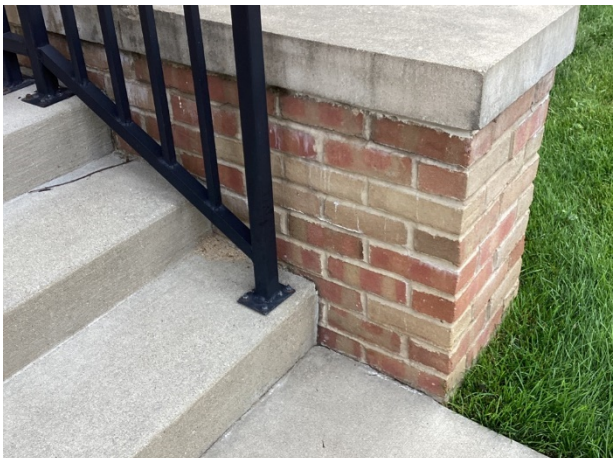
Masonry cracks and missing sealant at wing wall
– Note: opportunity for water accumulation
between stairs and wing wall masonry

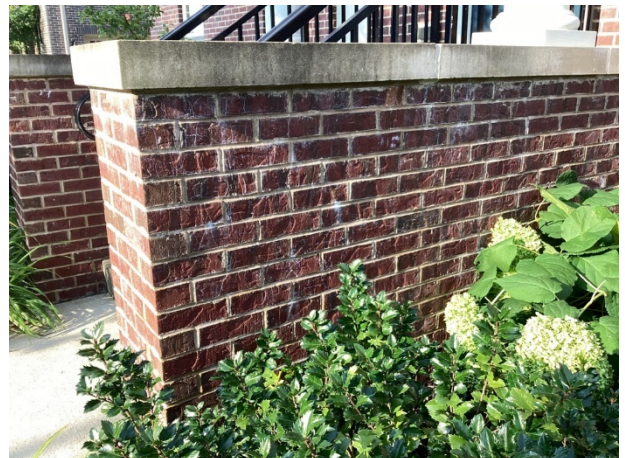
Wing wall efflorescence at Unit 71

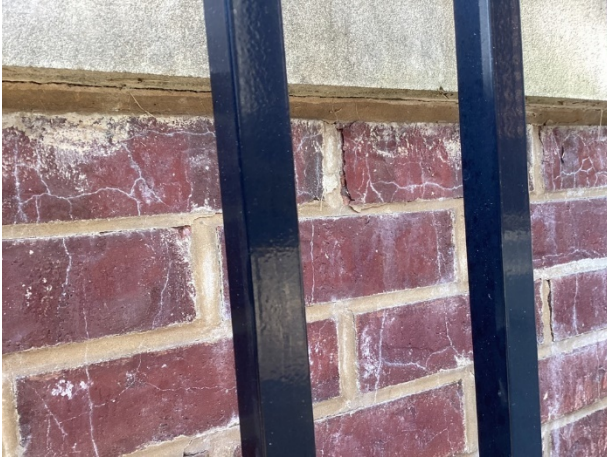
Cracks and scaling masonry at Unit 71

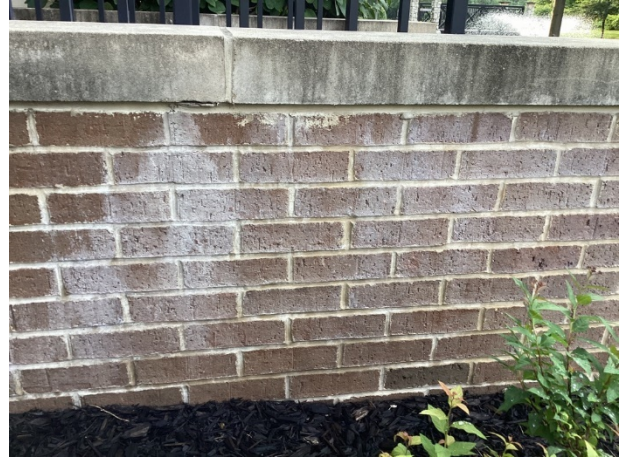
Wing wall efflorescence at Building 2

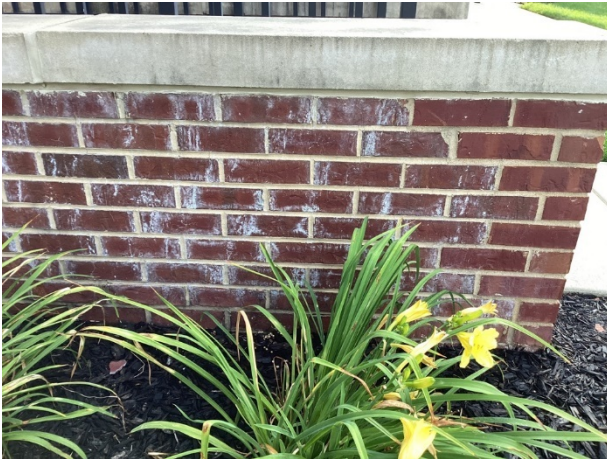
Efflorescence and masonry cracks at Unit 24

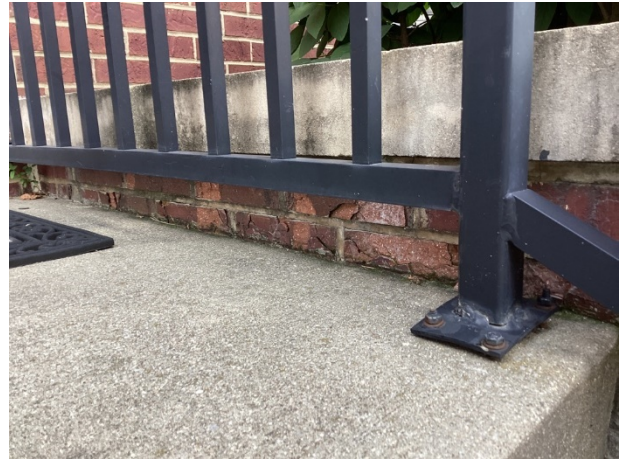
Spalled masonry at 1246 Duey Street

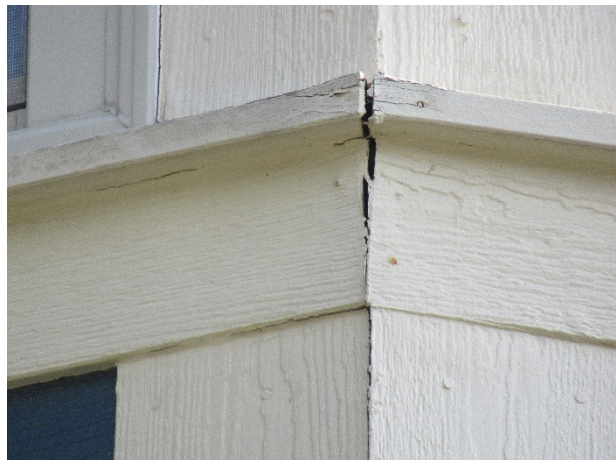
Condition: Fair overall with missing soffit, loose trim, damage, rot and deterioration evident.

Loose trim

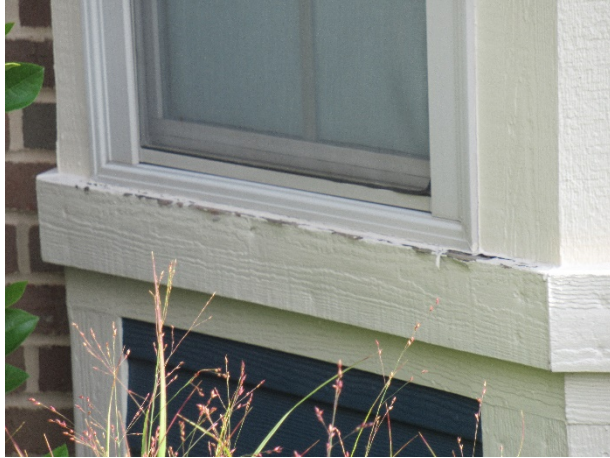
Finish rot and deterioration

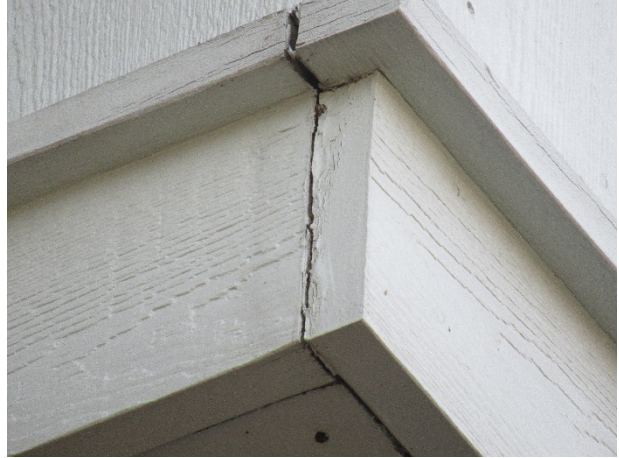
Loose trim boards

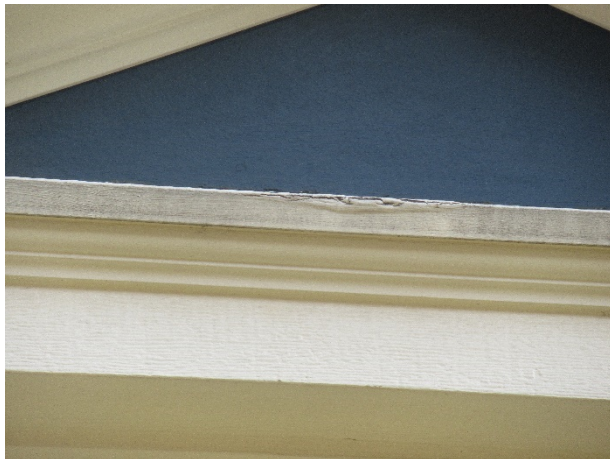
Finish deterioration

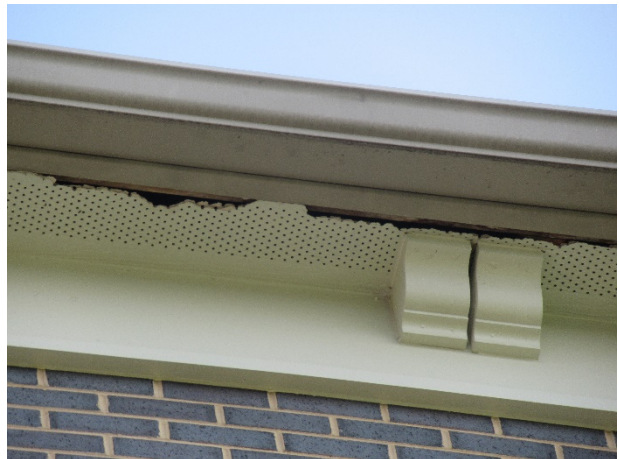
Missing soffit at Unit 98

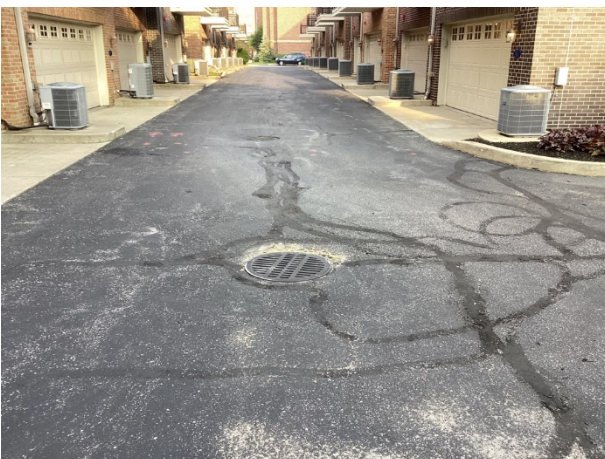
Asphalt pavement street overview with cracks and repairs

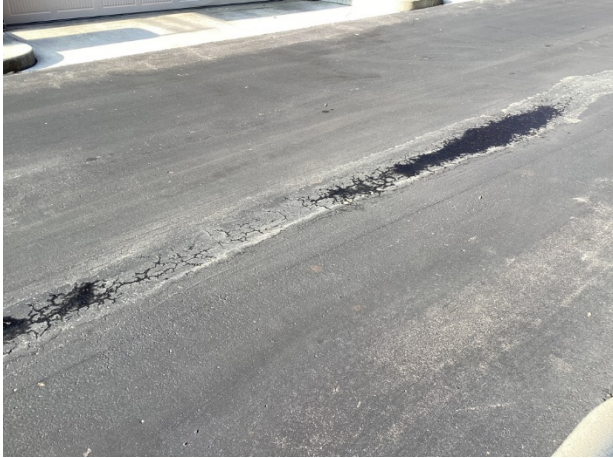
Standing water and cracks

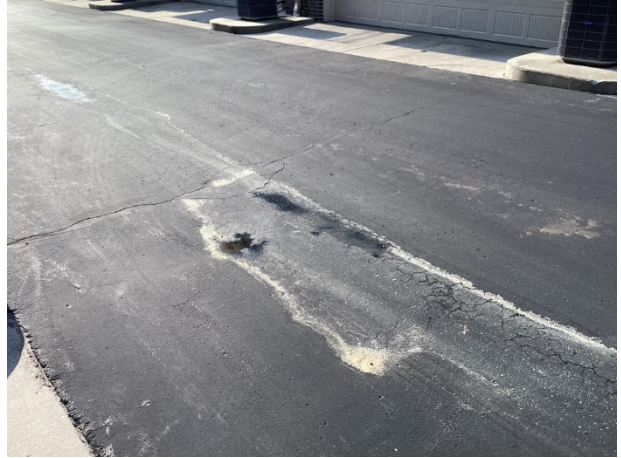
Pavement longitudinal cracks and alligator cracks

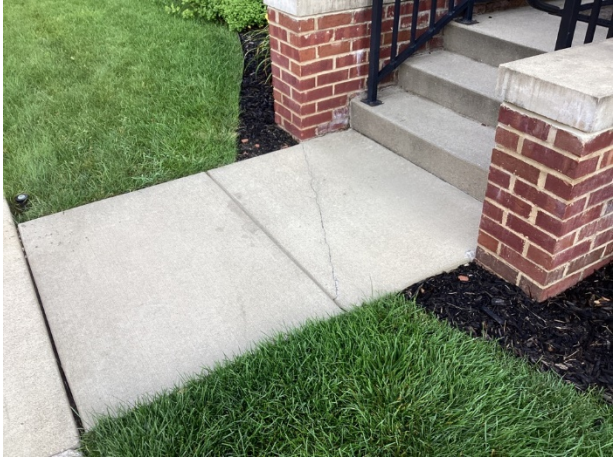
Condition: Good to fair overall with isolated cracks, settlement and previous repairs evident.

Sidewalk cracks

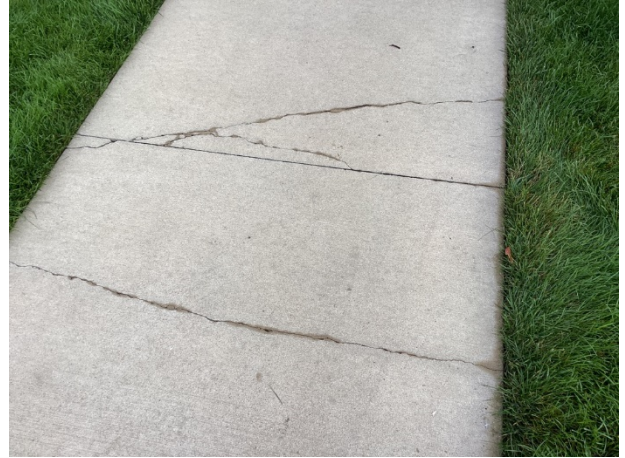
Sidewalk cracks

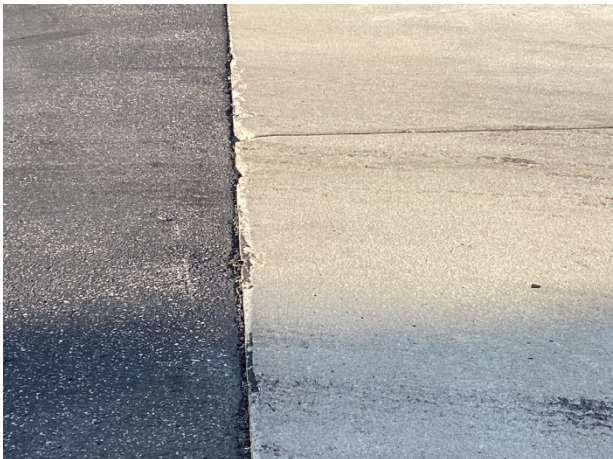
Spall at concrete apron

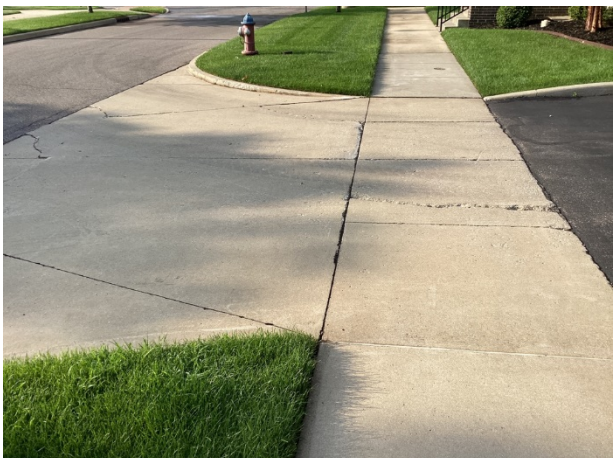
Cracks and spalls at concrete apron

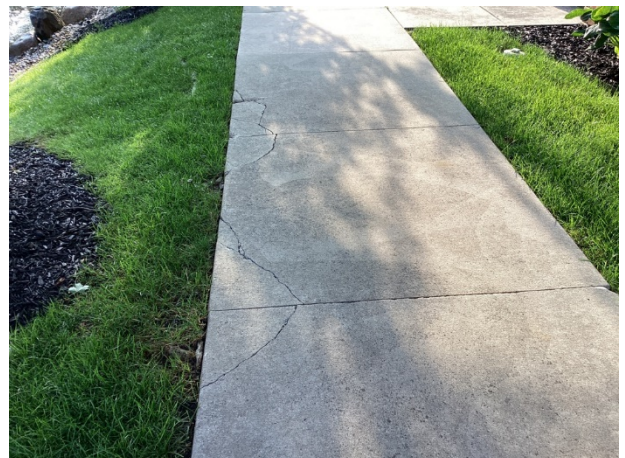
Sidewalk edge cracks likely due to settlement

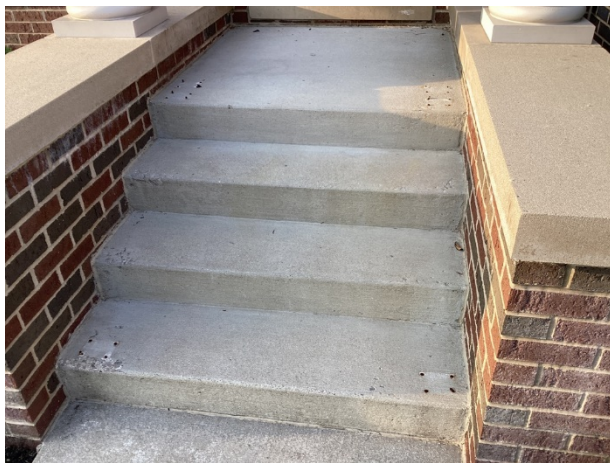
History and Condition: Good to fair overall with periodic cracks, spalled concrete, spalled concrete at railing attachment and railing rust evident. The Association performed isolated settlement remediation at Unit 46 recently funded through the operating budget. The rate of deterioration may be affected by the frequency of repairs of the wing walls as noted in Line Item, “**Walls, Masonry**”.

Concrete stairs with spall and removed railing

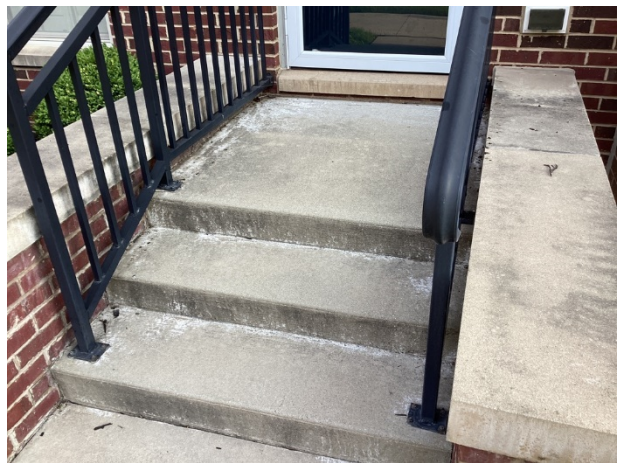
Concrete stairs with staining

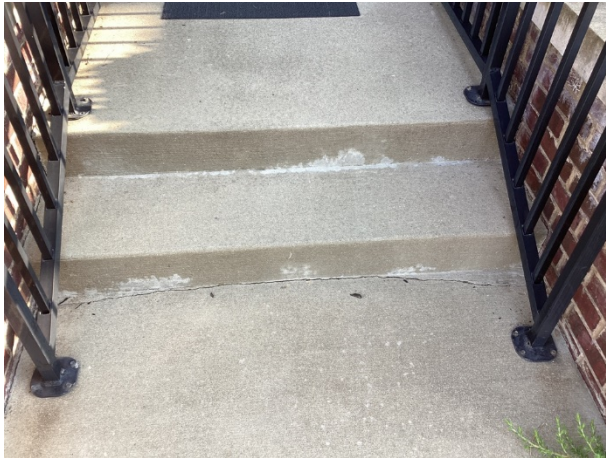
Stair cracks at Unit 87

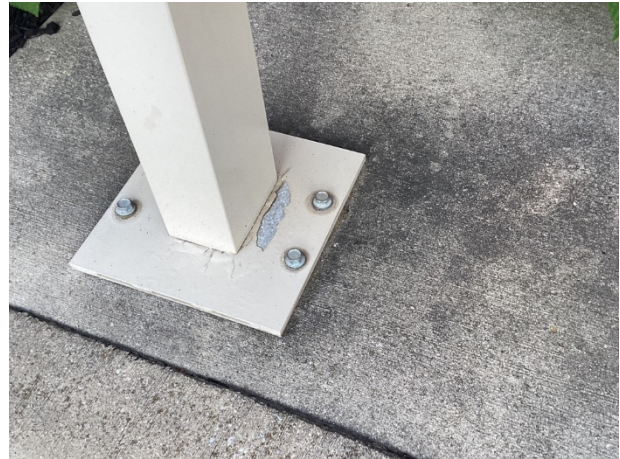
Condition: Good to fair overall with isolated finish deterioration evident.

Mailbox station minor finish deterioration

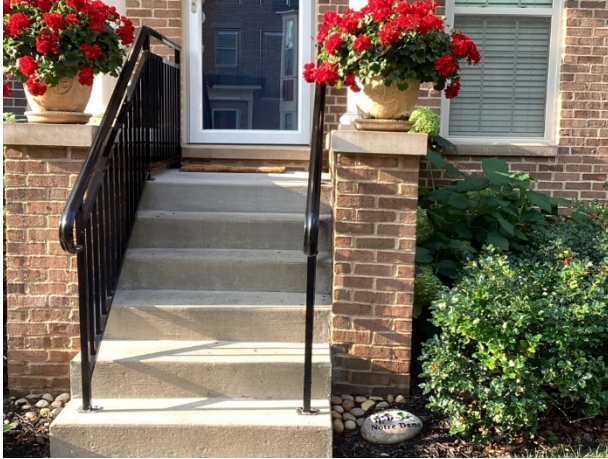
Condition: Good to fair overall with leaning railings, rusted fasteners and finish deterioration evident

Leaning railing at Unit 67

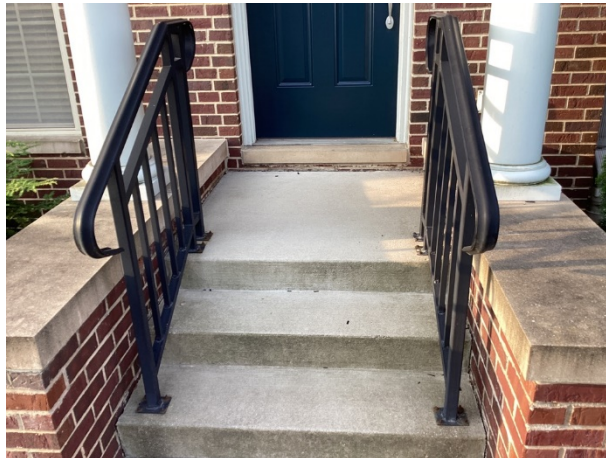
Railing with rusted fasteners
