Revised
FULL RESERVE STUDY
Champions Way
Homeowners Association, Inc.

South Bend, Indiana
Inspected - April 28, 2020
Revised - September 24, 2020

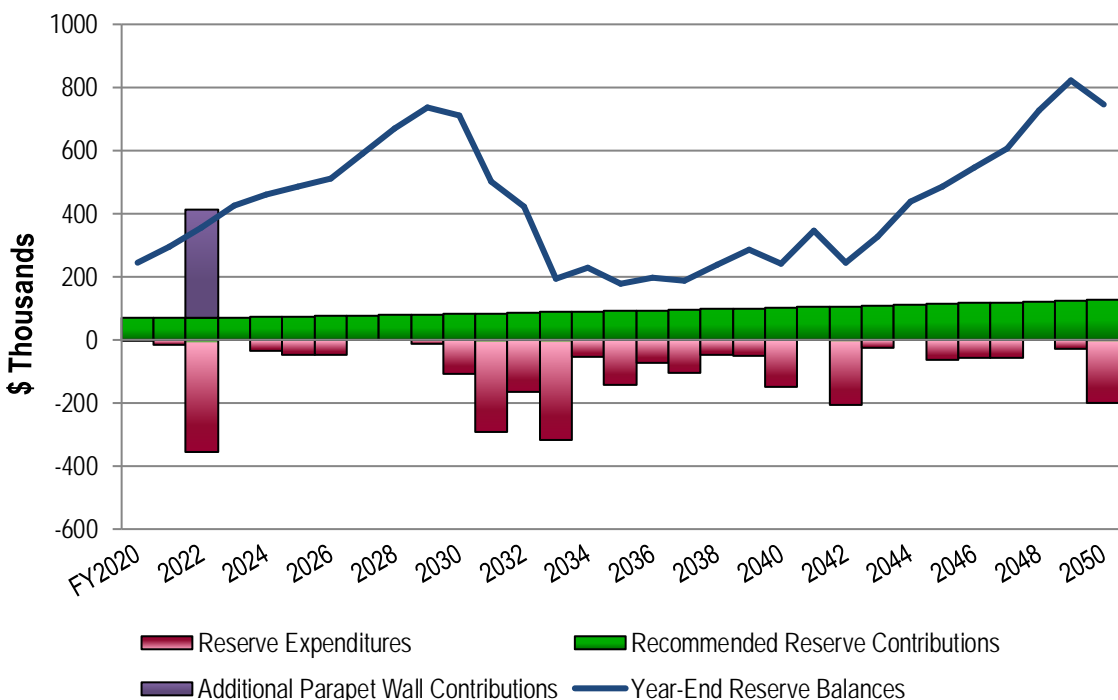
Year	Reserve Contributions (\$)	Reserve Balances (\$)	Year	Reserve Contributions (\$)	Reserve Balances (\$)	Year	Reserve Contributions (\$)	Reserve Balances (\$)
2021	68,450	295,689	2031	83,250	501,975	2041	103,550	344,390
2022	413,234	353,659	2032	85,100	422,397	2042	105,850	243,920
2023	69,950	424,192	2033	86,950	193,440	2043	108,200	326,104
2024	71,500	460,501	2034	88,850	229,174	2044	110,600	437,276
2025	73,050	485,910	2035	90,800	178,422	2045	113,050	486,433
2026	74,650	511,895	2036	92,800	196,960	2046	115,550	544,885
2027	76,300	589,020	2037	94,850	188,404	2047	118,100	604,704
2028	78,000	667,962	2038	96,950	237,050	2048	120,700	726,402
2029	79,700	735,942	2039	99,100	286,849	2049	123,350	820,781
2030	81,450	710,015	2040	101,300	240,402	2050	126,050	746,782

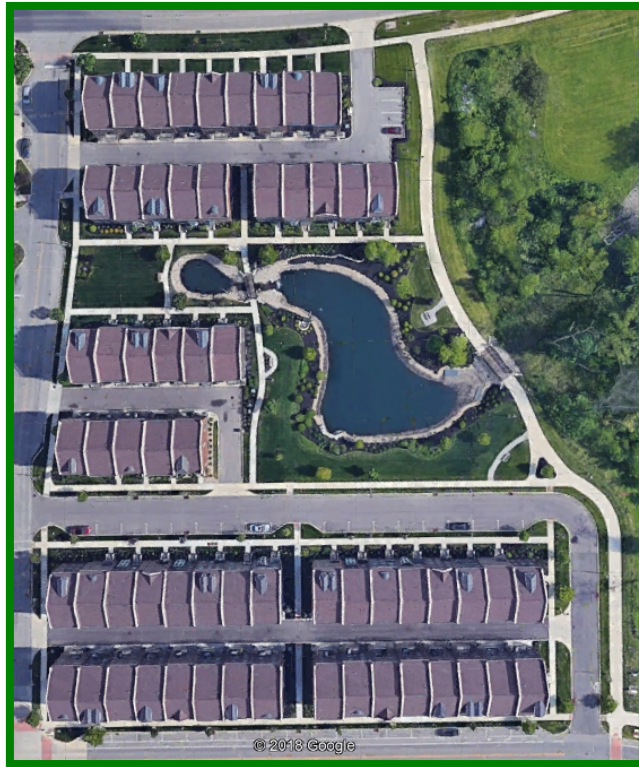
Our investigation includes Reserve Components or property elements as set forth in your Declaration. The Expenditure tables in Section 3 list the elements contained in this study. Our analysis begins by segregating the property elements into several areas of responsibility for repair and replacement.

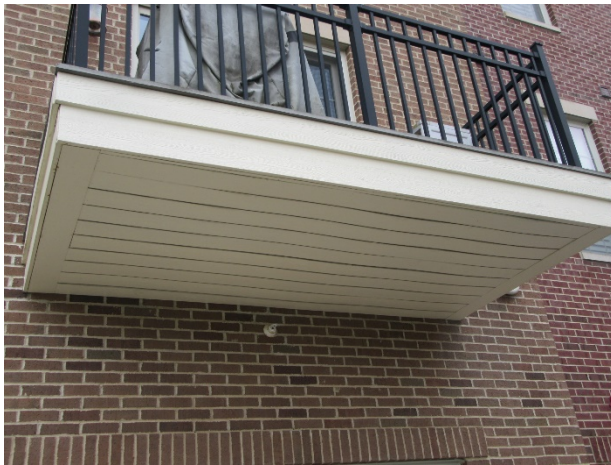
Typical deflected soffit

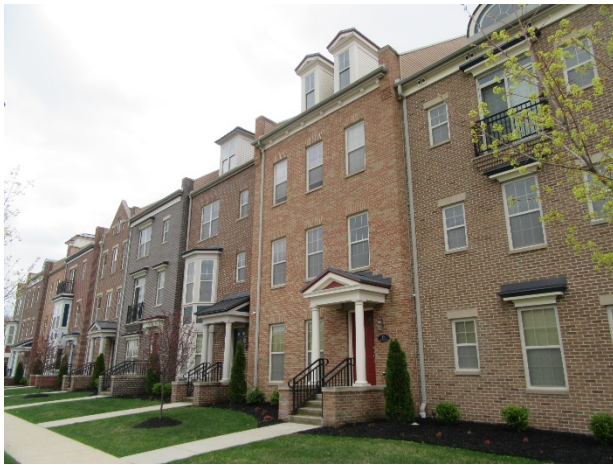
Exterior Building Elements

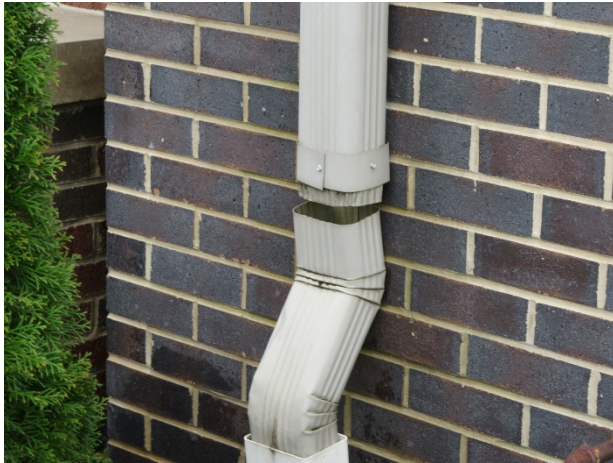
Disconnected downspout section at front of Unit 16

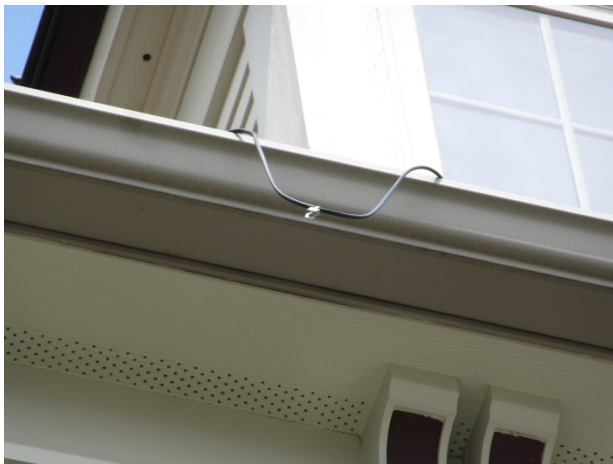
Loose heat tracer at Unit 51

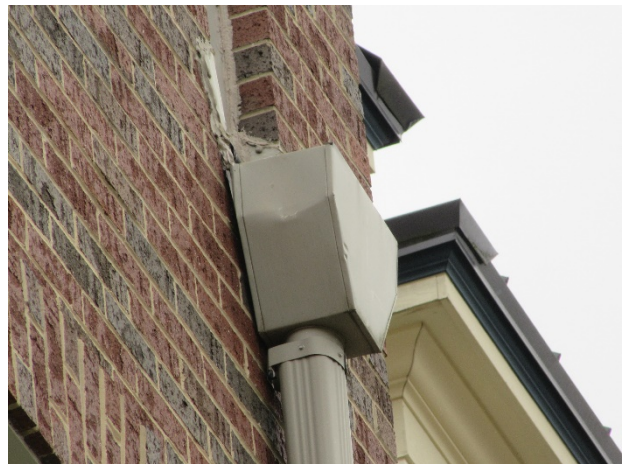
Additional sealants and likely overflow issue at Unit 35

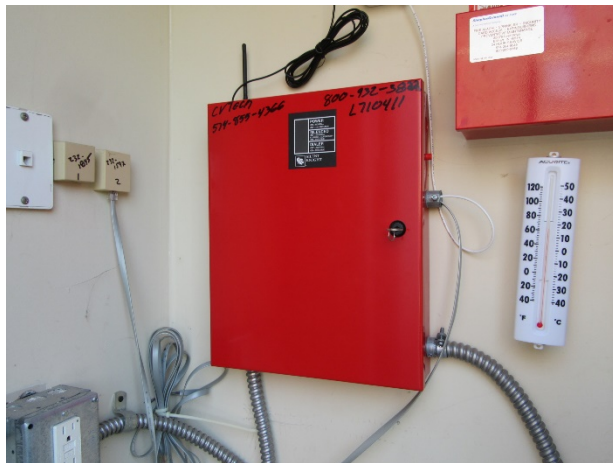
Conditions: Reported satisfactory

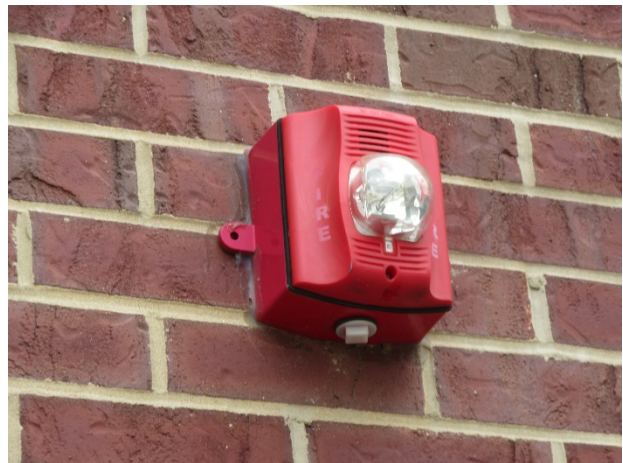
Audio/visual fixture

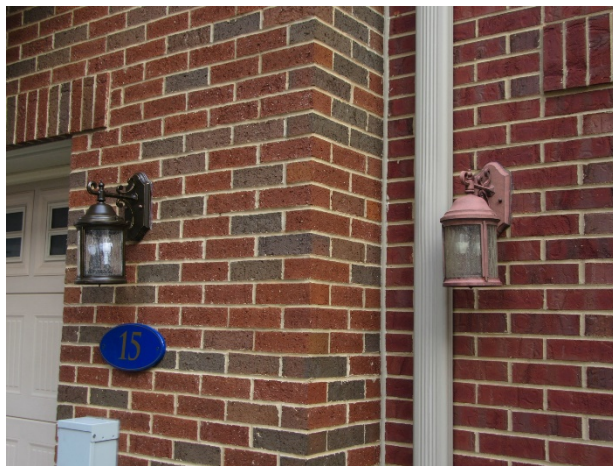
Varying age of light fixtures

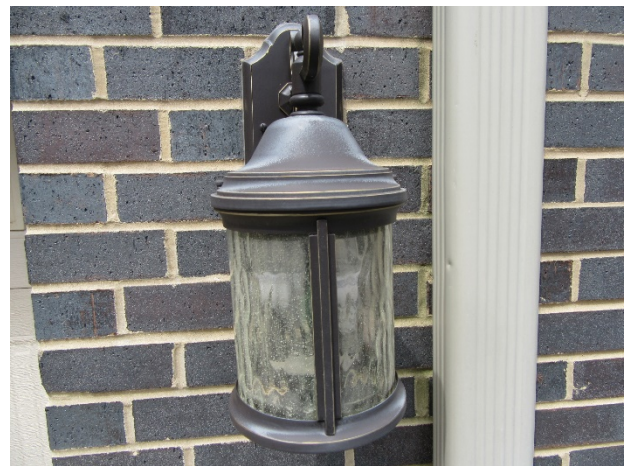
Finish deterioration at Unit 61

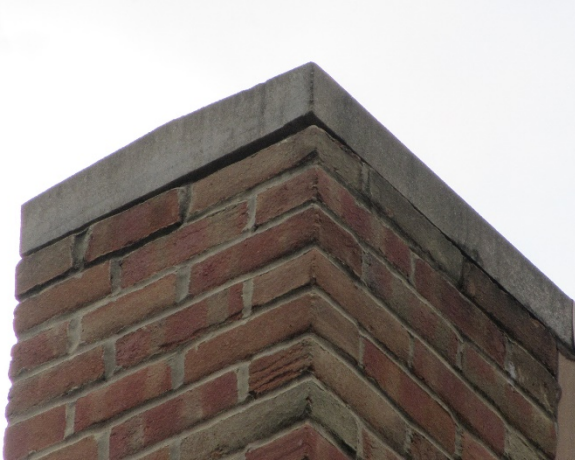
Due to the visual, non-invasive nature of this Reserve Study, we were unable to verify the precise conditions of flashing and interior damage at all locations. Our analysis is based on our visual inspection of current conditions and the assessment conducted by *KIL Architecture*.

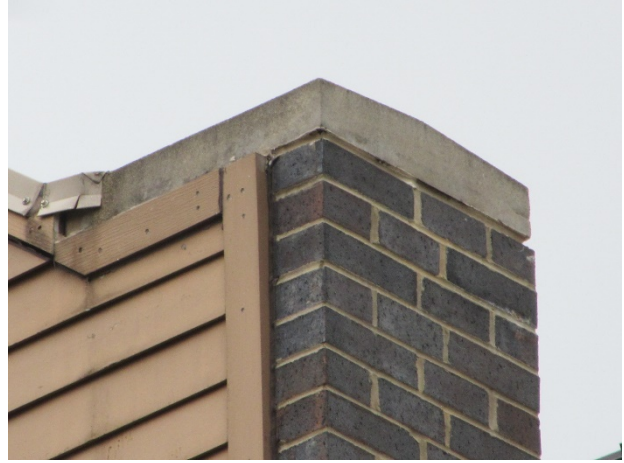
Siding installed offset from parapet wall at Unit 45 (opportunity for water infiltration)

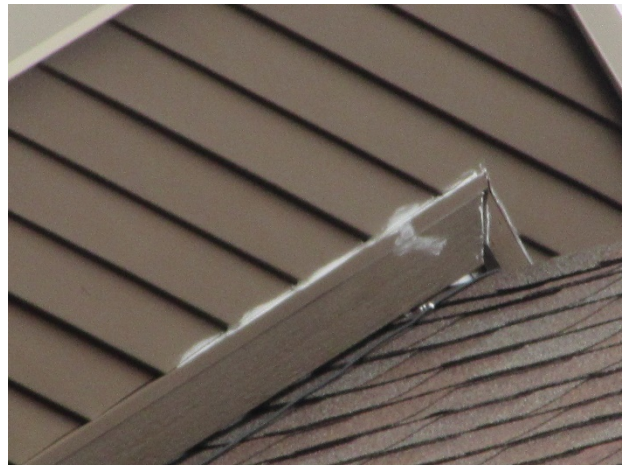
Discoloration at Unit 94

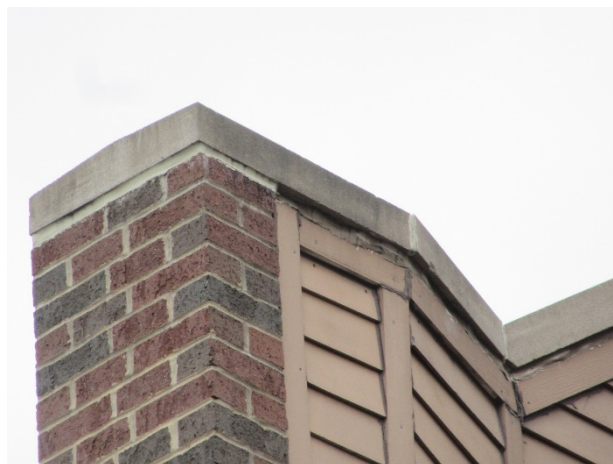
Coping overhang and sealant repair at Unit 21

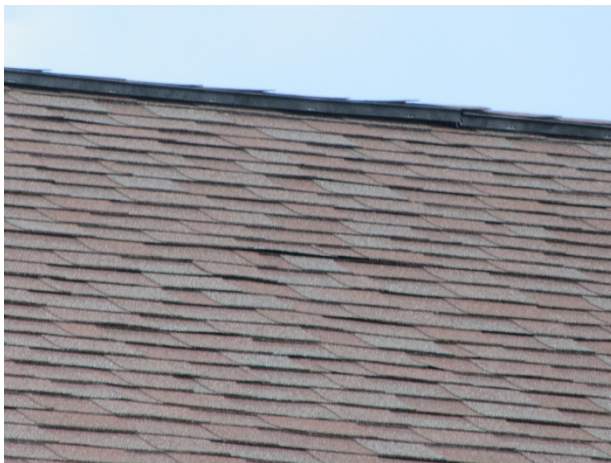
Sheathing deflection at Unit 24

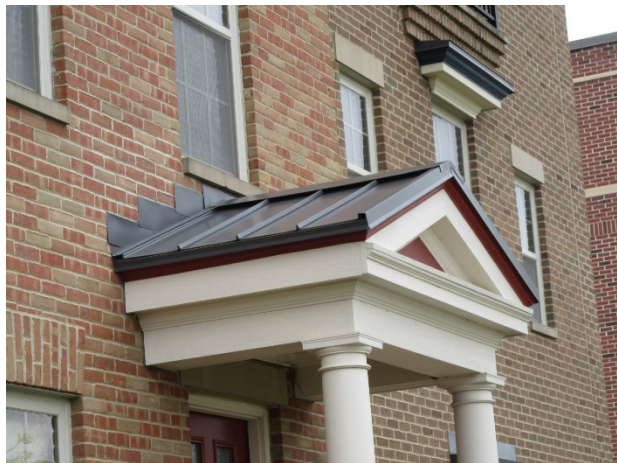
Condition: Good overall with no significant deterioration evident. Management and the Board do not report a history of leaks of the metal roofs.

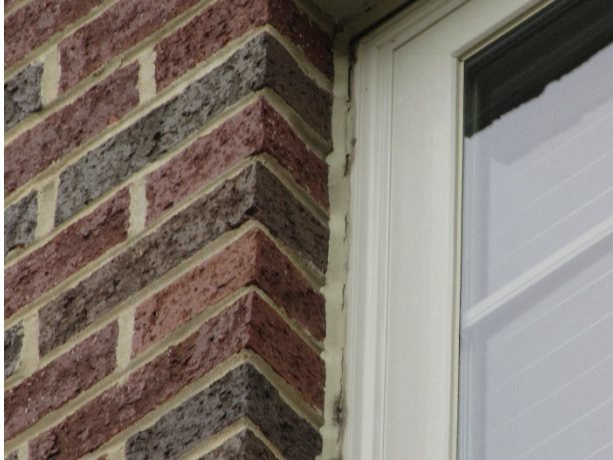
Adhesive sealant failure at front of Unit 17

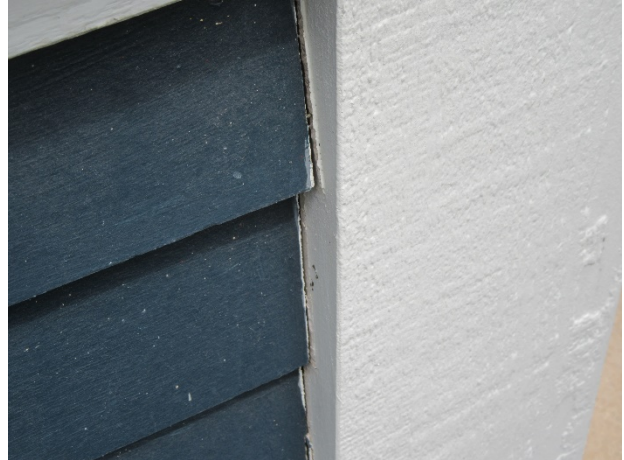
Lack of sealant at Unit 24

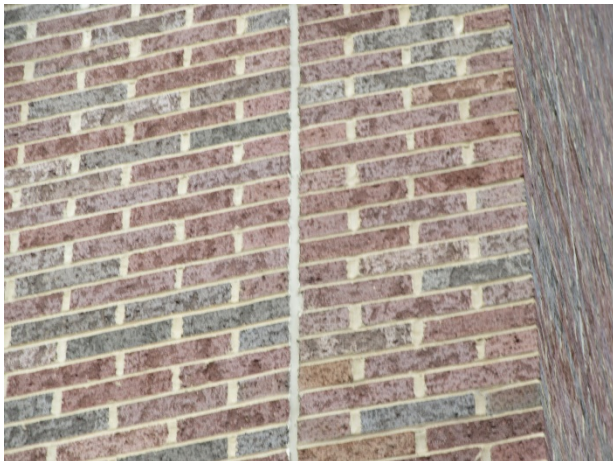
Control joint sealant in good condition

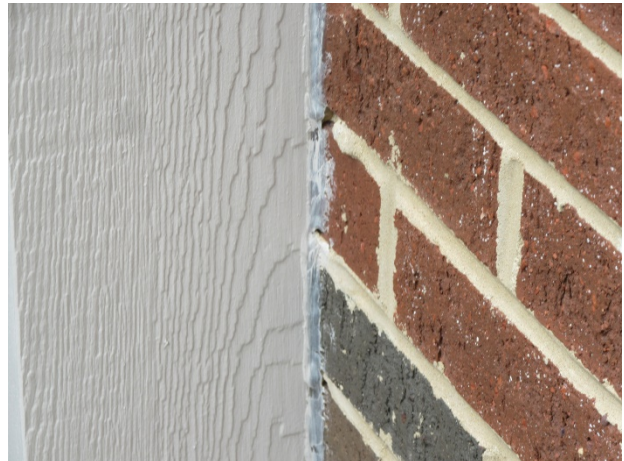
Overview of trim to masonry sealant

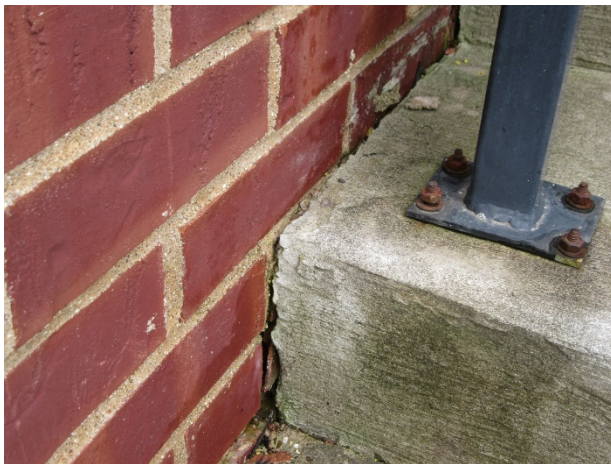
Opportunity for water accumulation between stairs and wing wall masonry (note deterioration)

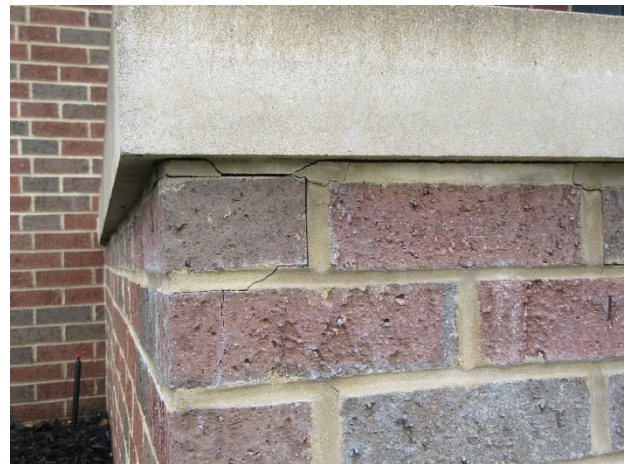
Wing wall mortar cracks at Unit 15 (note undersized capstones)

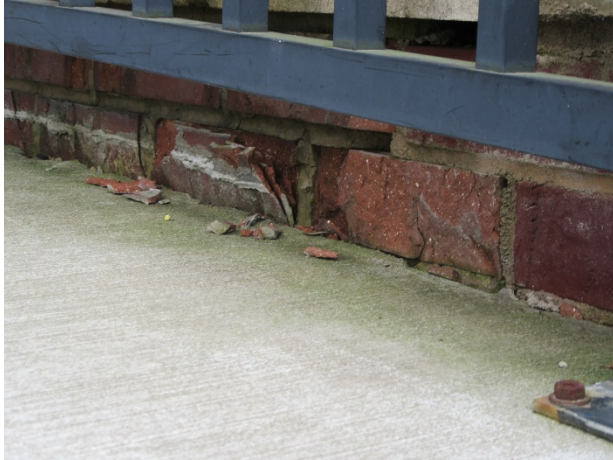
Spalled masonry at Unit 14

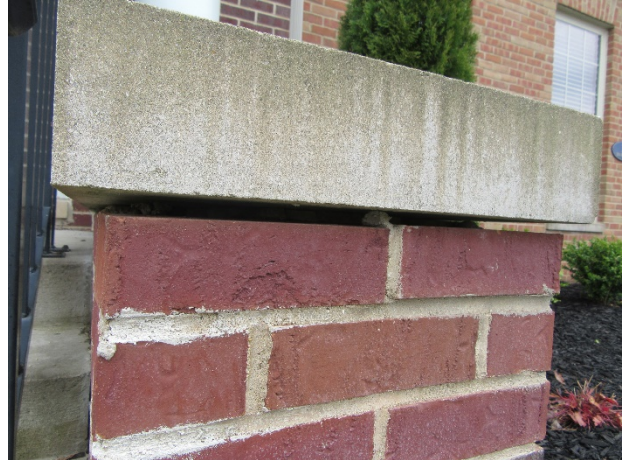
Missing mortar at Unit 12

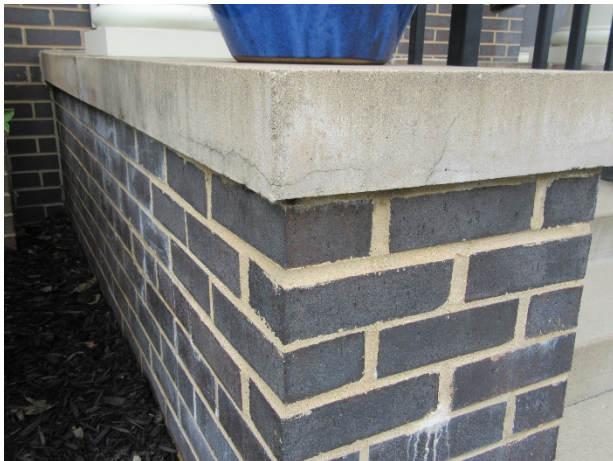
Capstone cracks and efflorescence at Unit 23

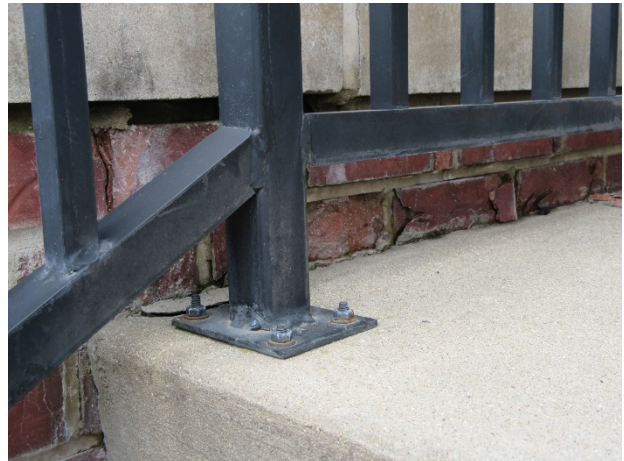
Spalled masonry and deterioration at Unit 24

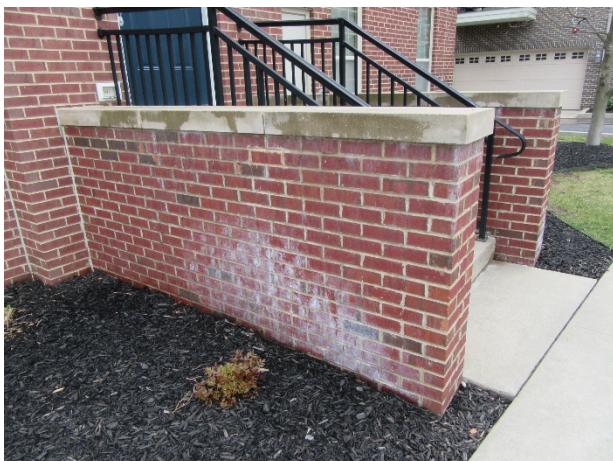
Efflorescence at Unit 46

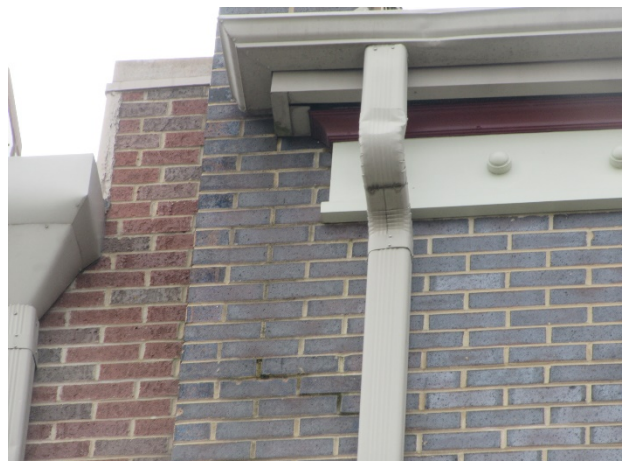
Mortar deterioration likely exacerbated by water runoff at Unit 16

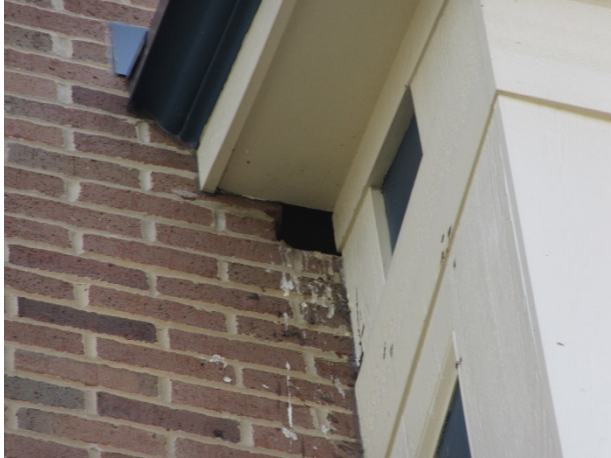
Gap at Unit 19 (noted bird infiltration)

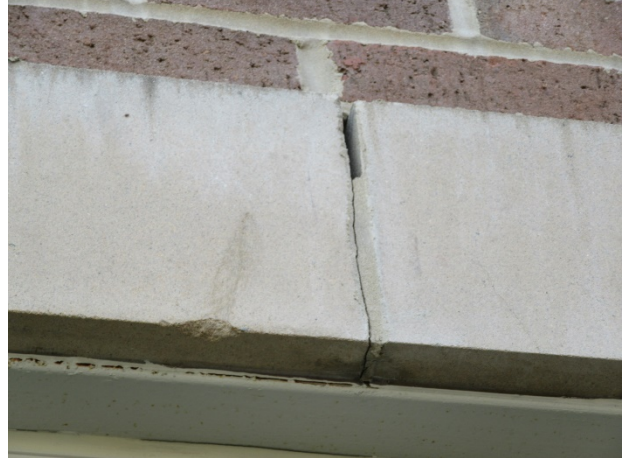
Mortar crack at Unit 19

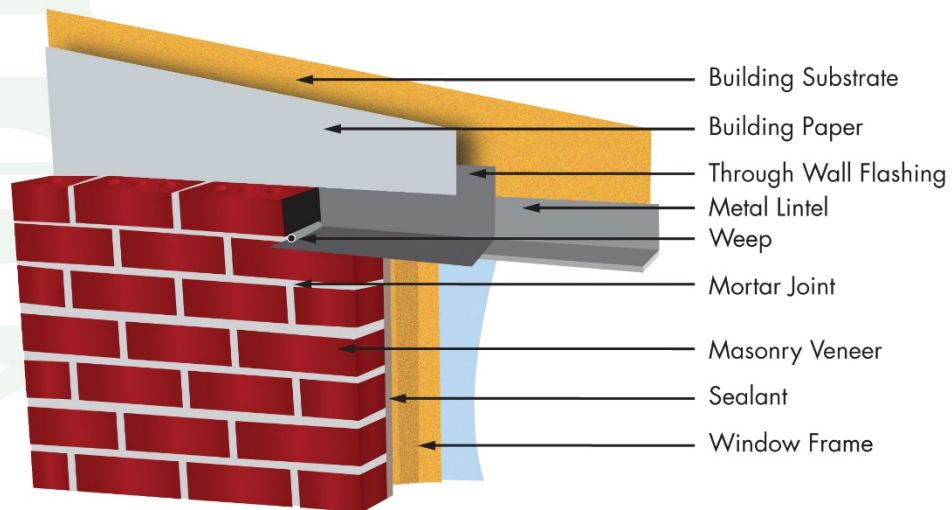
MASONRY WALL, METAL LINTEL AND WEEP SYSTEM DETAIL

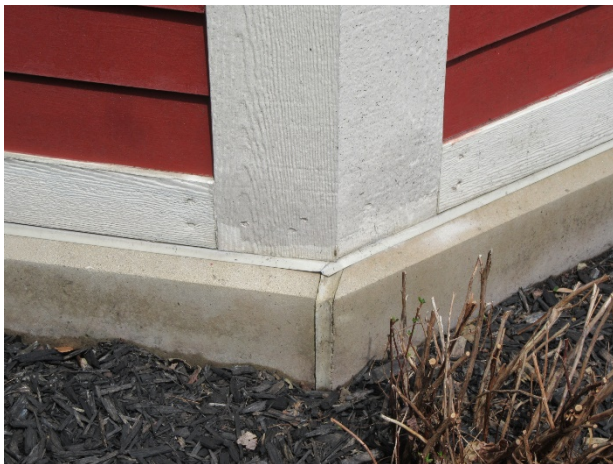
Condition: Good to fair overall with isolated missing soffit, loose trim, deterioration and damage evident

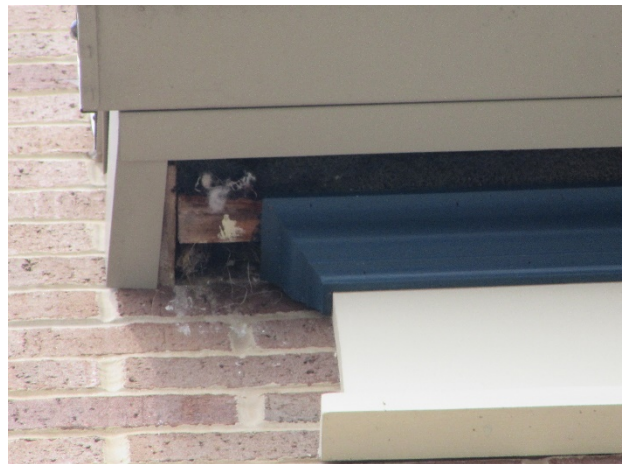
Missing soffit at Unit 54

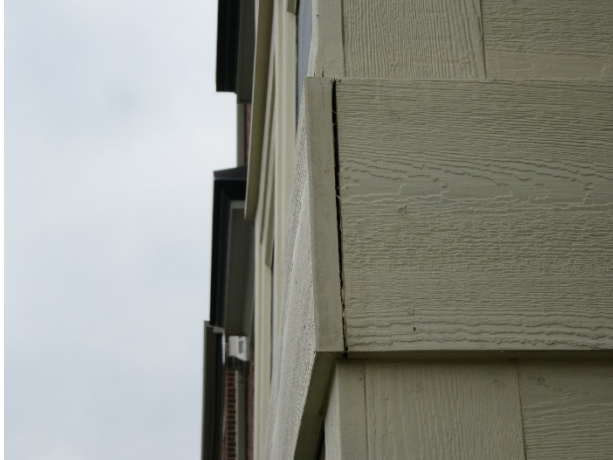
Loose trim at Unit 35

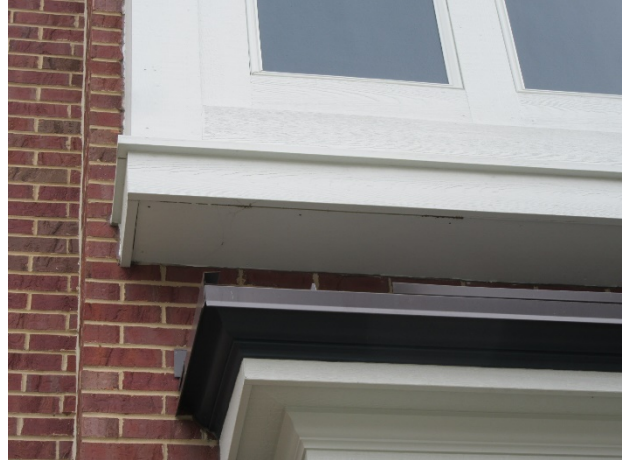
Deterioration and potential water infiltration at Unit 46

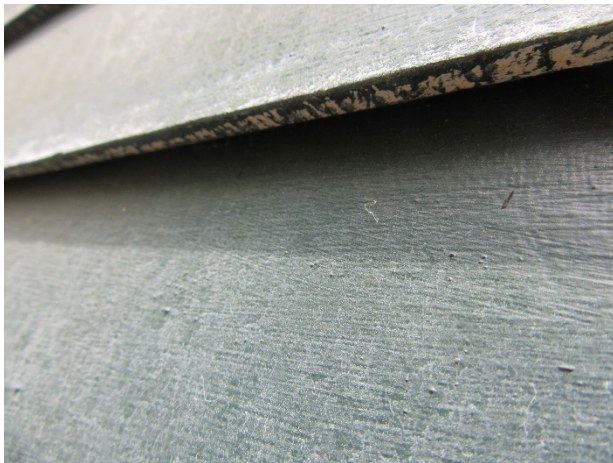
Paint coverage issue at front of Unit 32

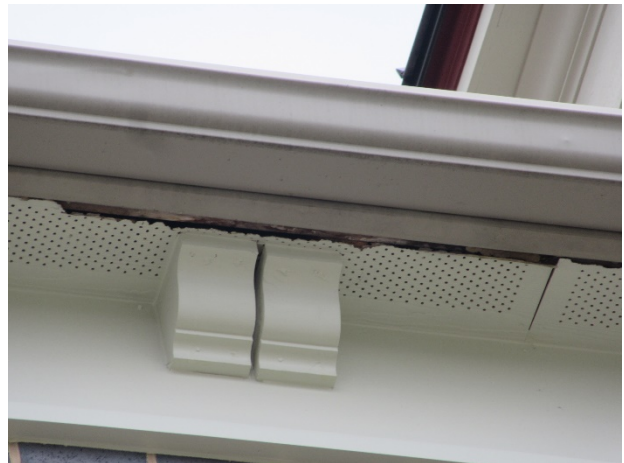
Soffit damage at Unit 98

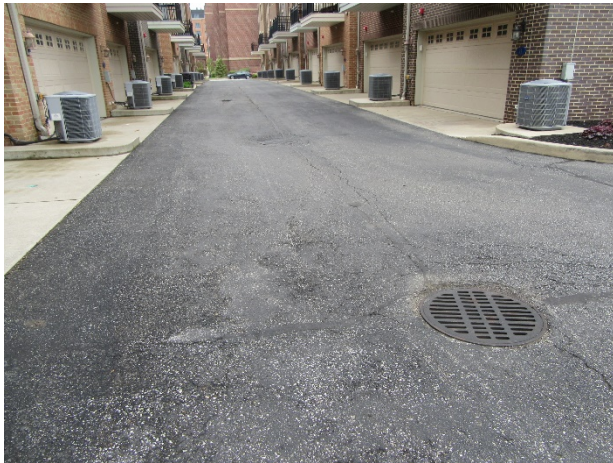
Overview of access drive between Buildings 1, 2 and 3

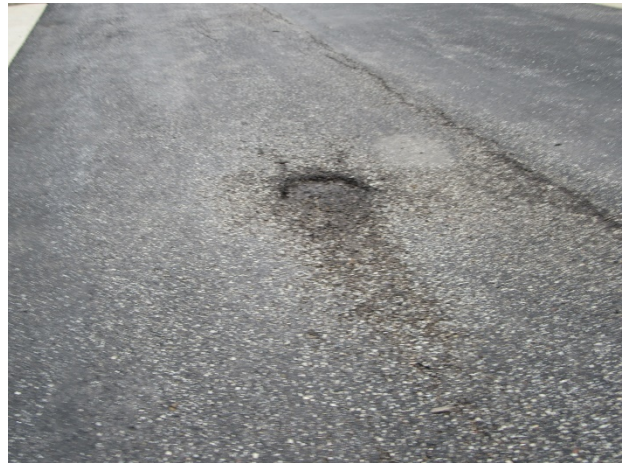
Localized deterioration near Unit 32

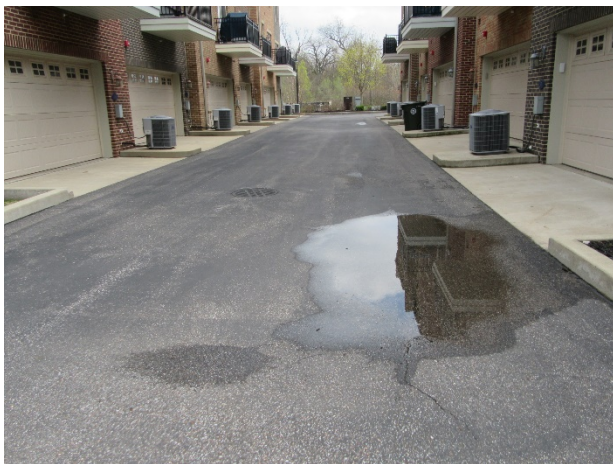
Overview of access drive between Buildings 4 and 5 (note water accumulation)

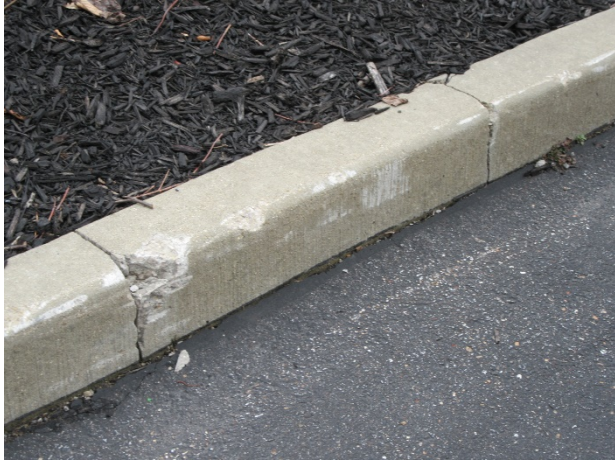
Curb damage near Unit 41

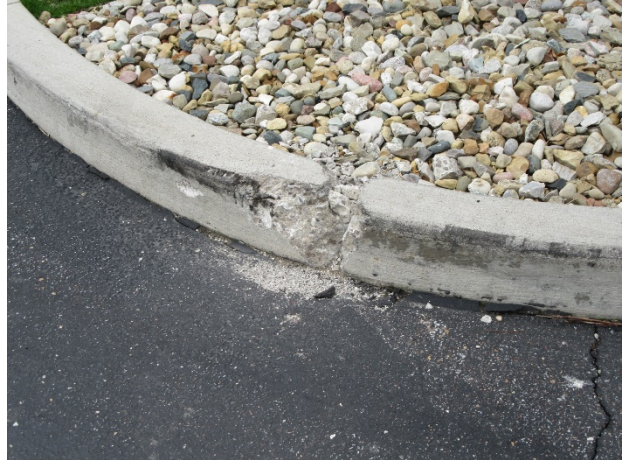
Curb damage near Unit 55

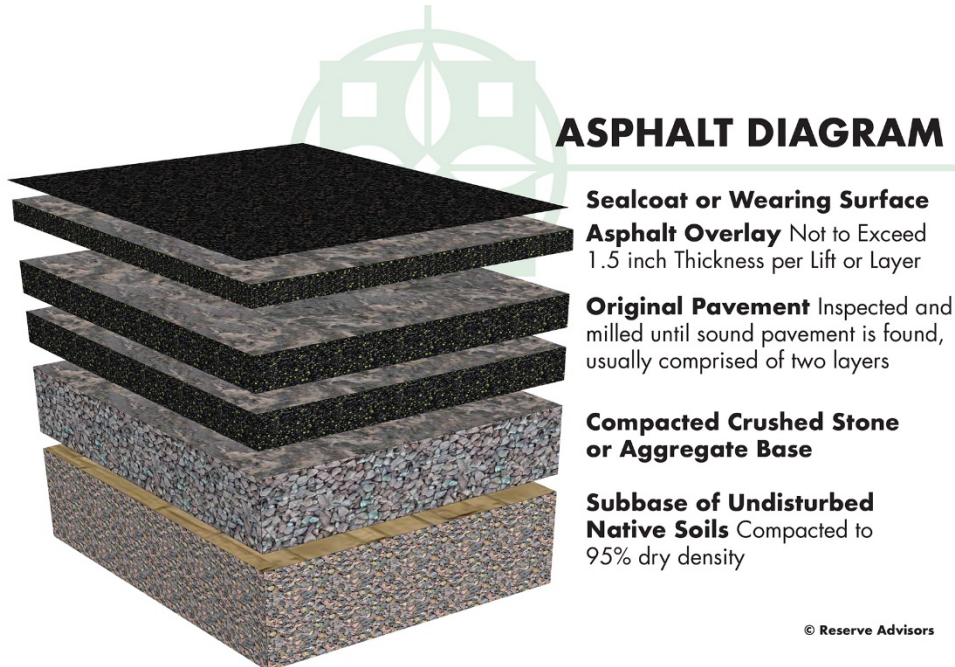
The manner of repaving is either a mill and overlay or total replacement. A mill and overlay is a method of repaving where cracked, worn and failed pavement is mechanically removed or milled until sound pavement is found. A new layer of asphalt is overlaid atop the remaining base course of pavement. Total replacement includes

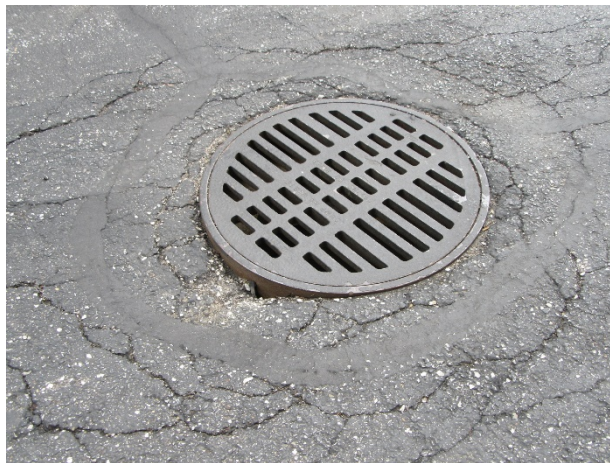
Settlement near Unit 11

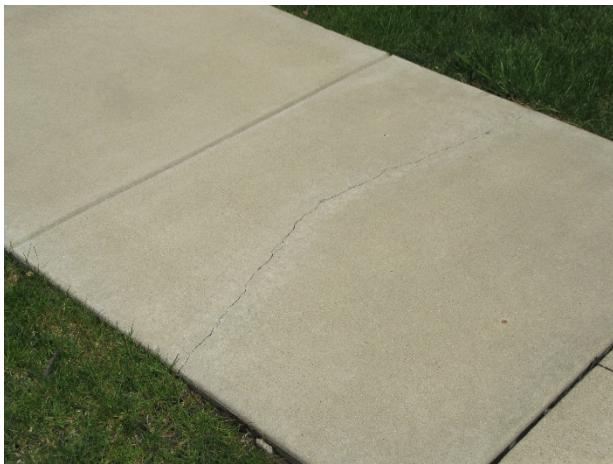
Condition: Good to fair overall with isolated cracks evident

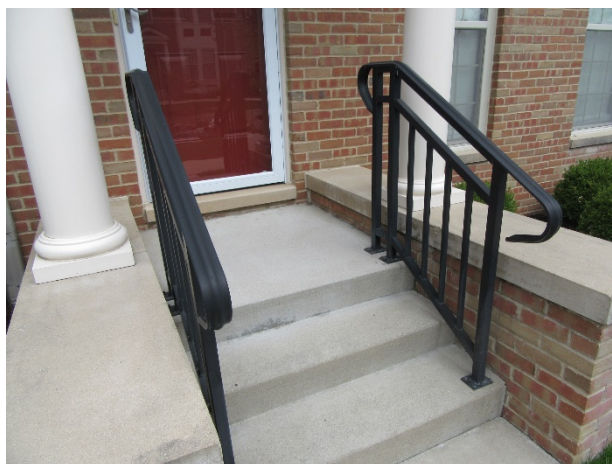
Condition: Good overall. The rate of deterioration may be affected by the frequency of repairs of the wing walls as noted in Line Item, "**Walls, Masonry**".

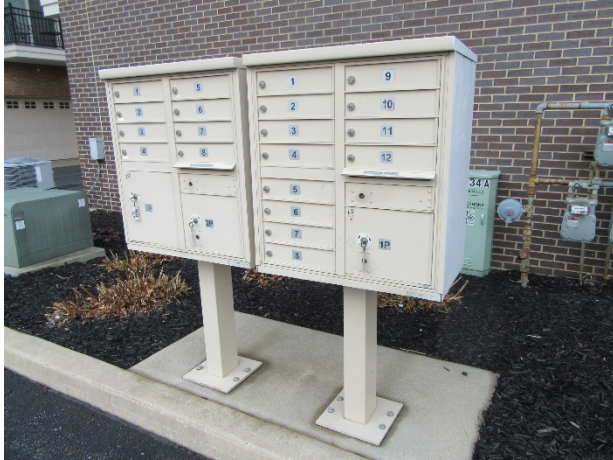
Mailbox station overview

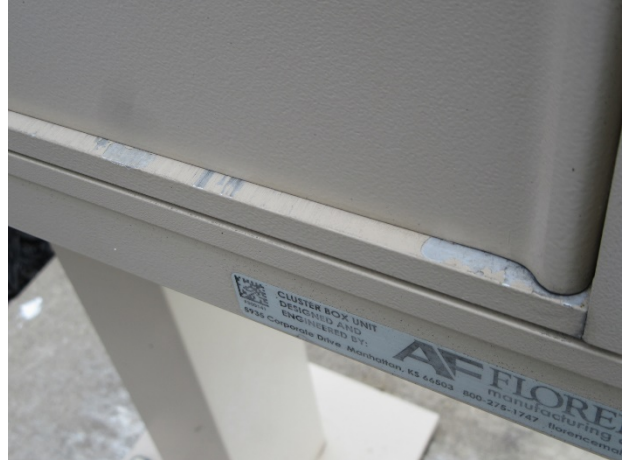
Minor finish deterioration near Unit 55

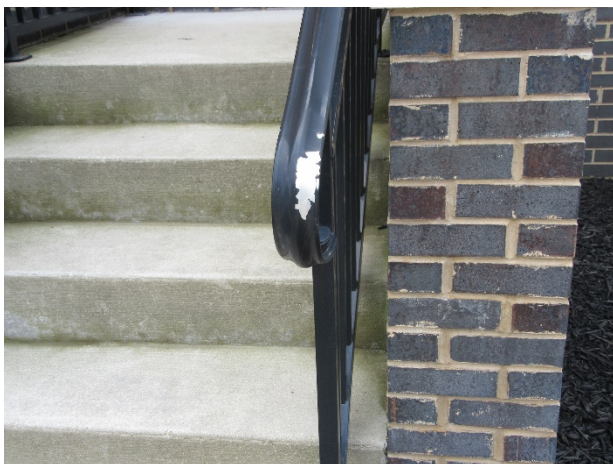
Finish deterioration at Unit 66

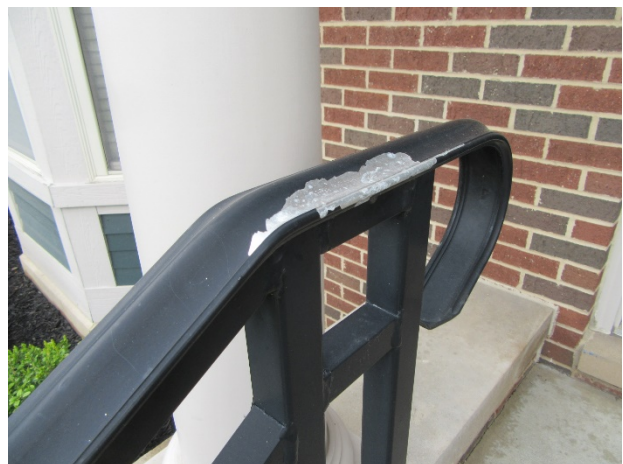
Finish deterioration at Unit 17

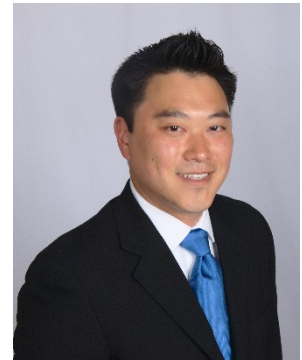
The following is a partial list of clients served by Andrew McGowan demonstrating his breadth of experiential knowledge of community associations in construction and related buildings systems.
