Champions Way Homeowners Association, Inc.

August 9, 2023 • South Bend, IN

RESERVE STUDY

Champions Way Homeowners Association, Inc.
South Bend, Indiana

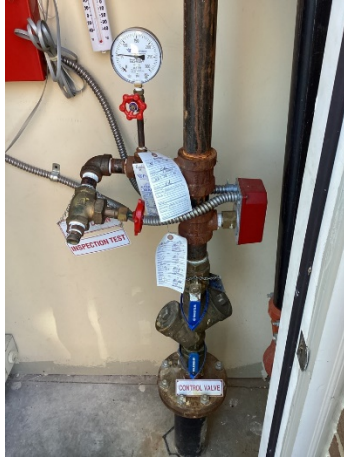
Rusted sprinkler valves

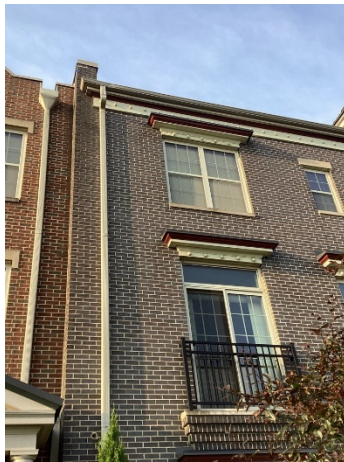
Condition: Good to fair overall with isolated fastener rust and dented sections evident.

Aluminum gutter and downspout with damaged gutter

- Repair and refasten any loose gutter fasteners
- Repair and seal any leaking seams or end caps
- Verify downspouts discharge away from foundations

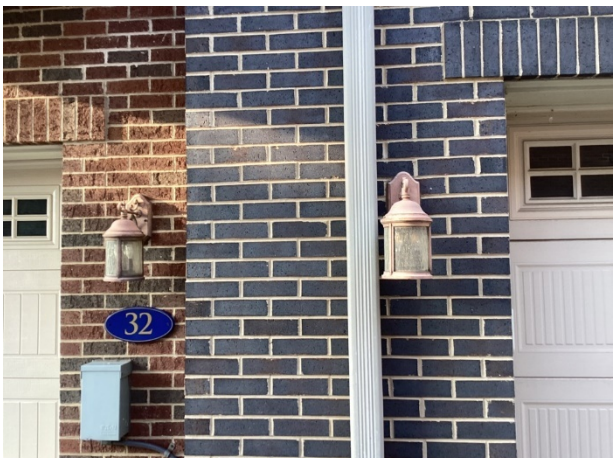
Condition: Fair overall with finish deterioration and mis-matched fixtures evident. We note replaced fixtures.

Wall mounted light fixtures at garages

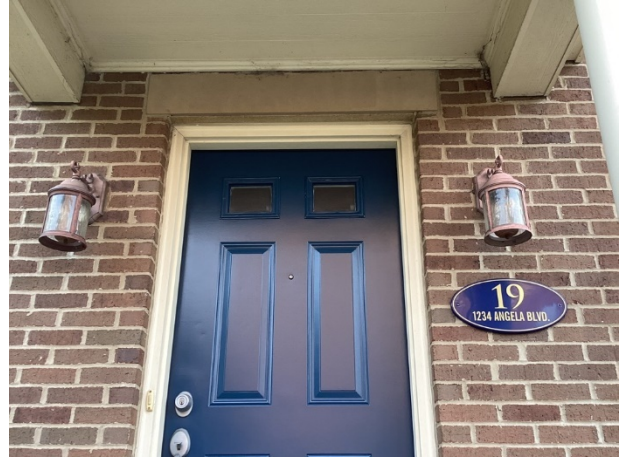
Wall mounted light fixtures at front entryway

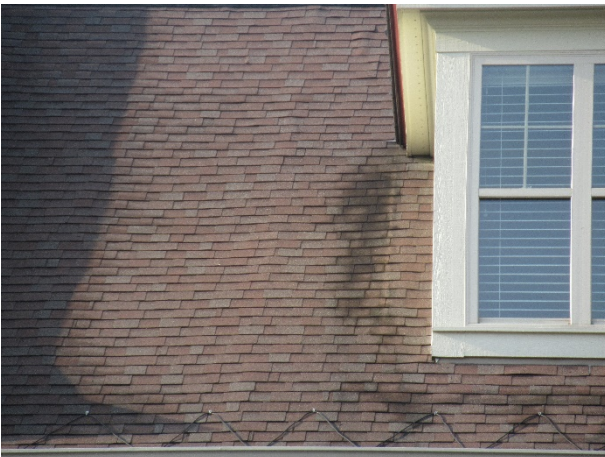
Condition: Good to fair overall with staining, minor shingle lift, and isolated sheathing deflection. Management reports a limited history of leaks at the parapet walls. Following the recent remediation of the parapet walls, Management does not report leaks.

Asphalt shingle roof staining

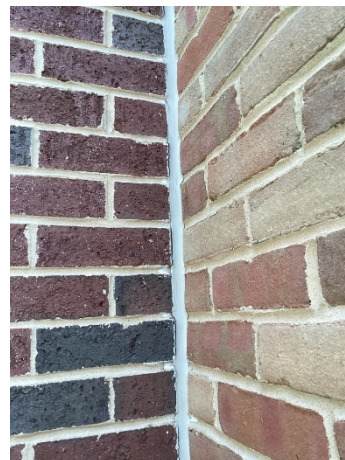
Adhesion failure at Unit 43

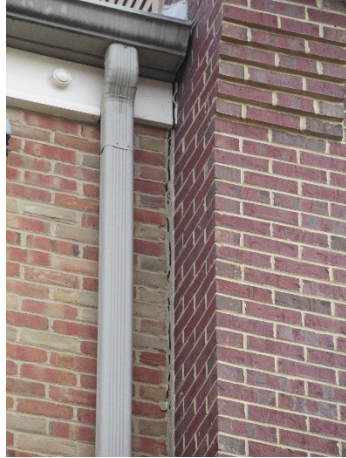
Brittle sealants and cohesive failure at Unit 72

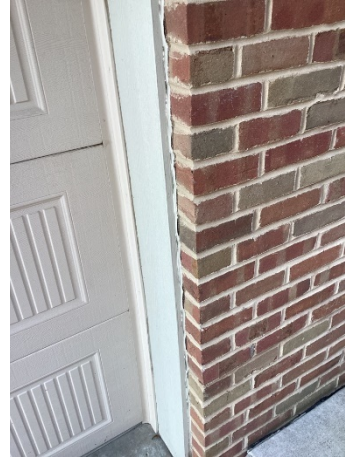
Cohesive failure at Unit 85

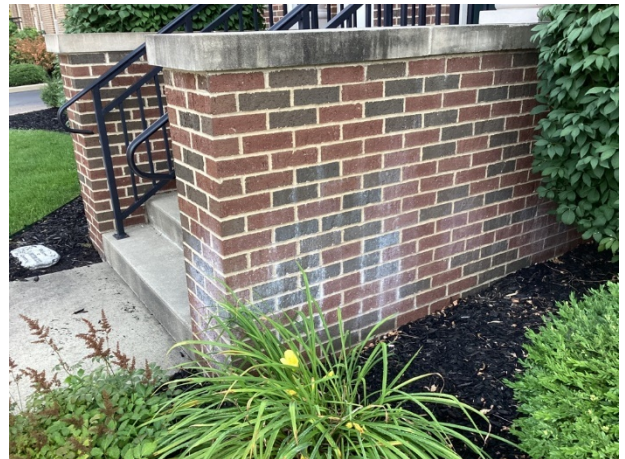
- Minimal previous repairs evident
- Efflorescence is visible (Efflorescence is not a safety concern. However, it can be an indication of water infiltration, masonry saturation, improper drainage behind the façade or another underlying issue.)
- Lintels exhibit rust

Efflorescence at wing wall

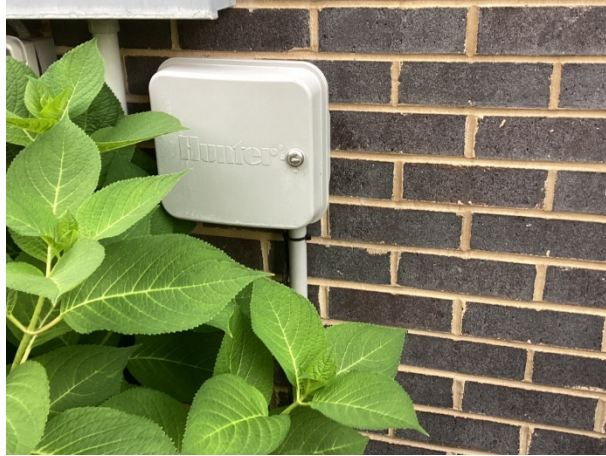
Condition: Satisfactory operational condition and Management does not report any deficiencies

Irrigation system controller

- Semi-annually:
 - Conduct seasonal repairs which includes valve repairs, controller repairs, partial head replacements and pipe repairs
 - Blow out irrigation water lines and drain building exterior faucets each fall if applicable

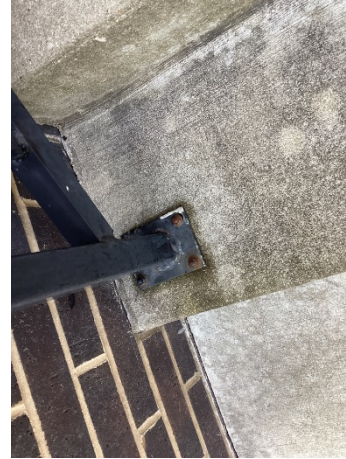
Rusted fasteners at Unit 45

- Annually:
 - Inspect for damage, and excessive finish deterioration or corrosion
 - Test security of railings and inspect connection fasteners
