Champions Way Homeowners Association, Inc.

August 9, 2023 • South Bend, IN

RESERVE STUDY

Champions Way Homeowners Association, Inc.
South Bend, Indiana

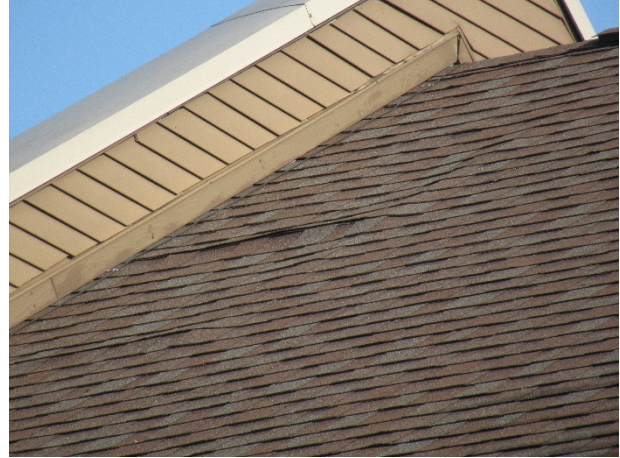
Condition: Good to fair overall with staining, minor shingle lift, and isolated sheathing deflection. Management reports a limited history of leaks at the parapet walls. Following the recent remediation of the parapet walls, Management does not report leaks.

Sheathing deflection

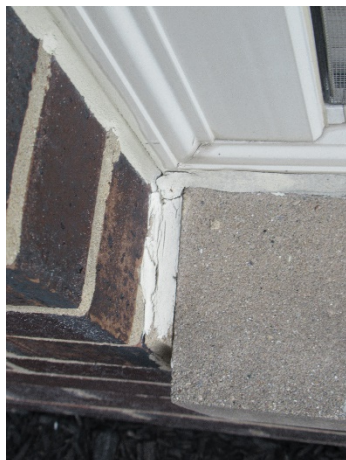
Sealant cracks

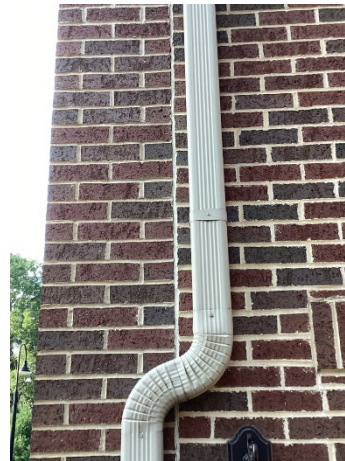
Brittle sealants

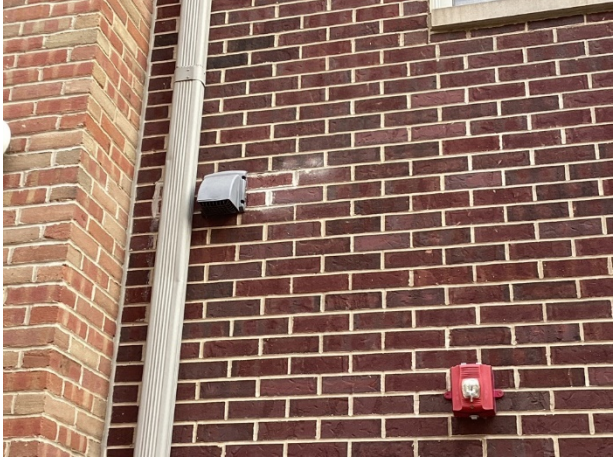
Previous repairs

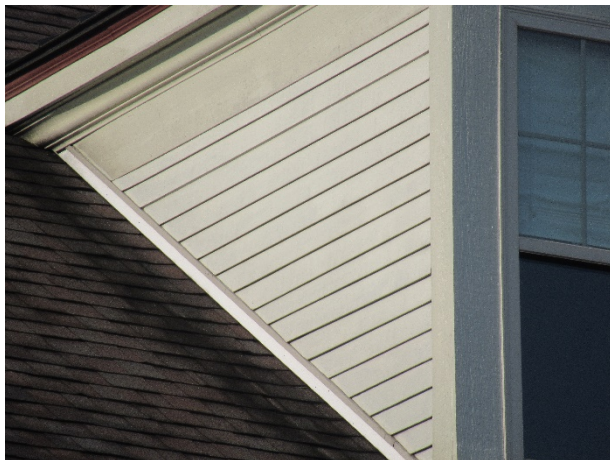
Condition: Fair overall with missing soffit, loose trim, damage, rot and deterioration evident.

Siding overview

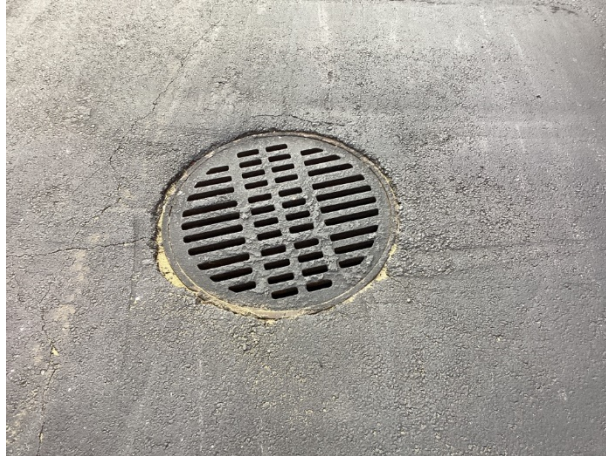
Catch basin

Component Detail Notes: Erosion causes settlement around the collar of catch basins. Left unrepaired, the entire catch basin will shift and need replacement.

- Annually:
 - Inspect and repair any settlement and collar cracks
 - Ensure proper drainage and inlets are free of debris
 - If property drainage is not adequate in heavy rainfall events, typically bi-annual cleaning of the catch basins is recommended

Expenditure Detail Notes: Expenditure timing and costs are depicted in the **Reserve Expenditures** table in Section 3. We recommend the Association plan for inspections and capital repairs to the catch basins in conjunction with repaving.

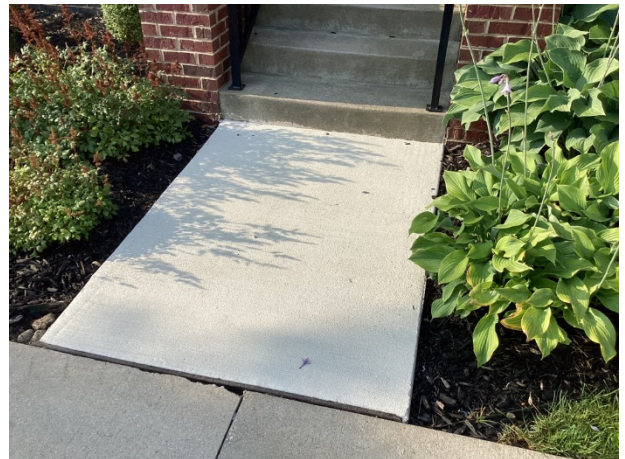
Replaced section

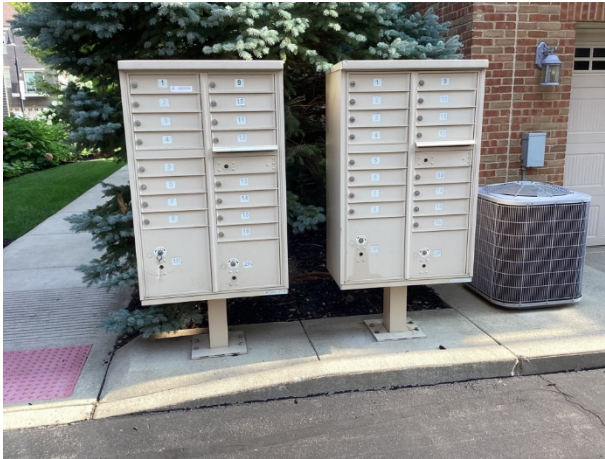
Condition: Good to fair overall with isolated finish deterioration evident.

Mailbox stations

- As-needed:
 - Inspect and repair damage, vandalism, and finish deterioration
 - Verify posts are anchored properly
